SURVEYS, ATTEMPTS AT RESTORATION, AND INVESTIGATIONS OF THE ARCHITECTURE OF THE CATHEDRAL OF ST. SOPHIA

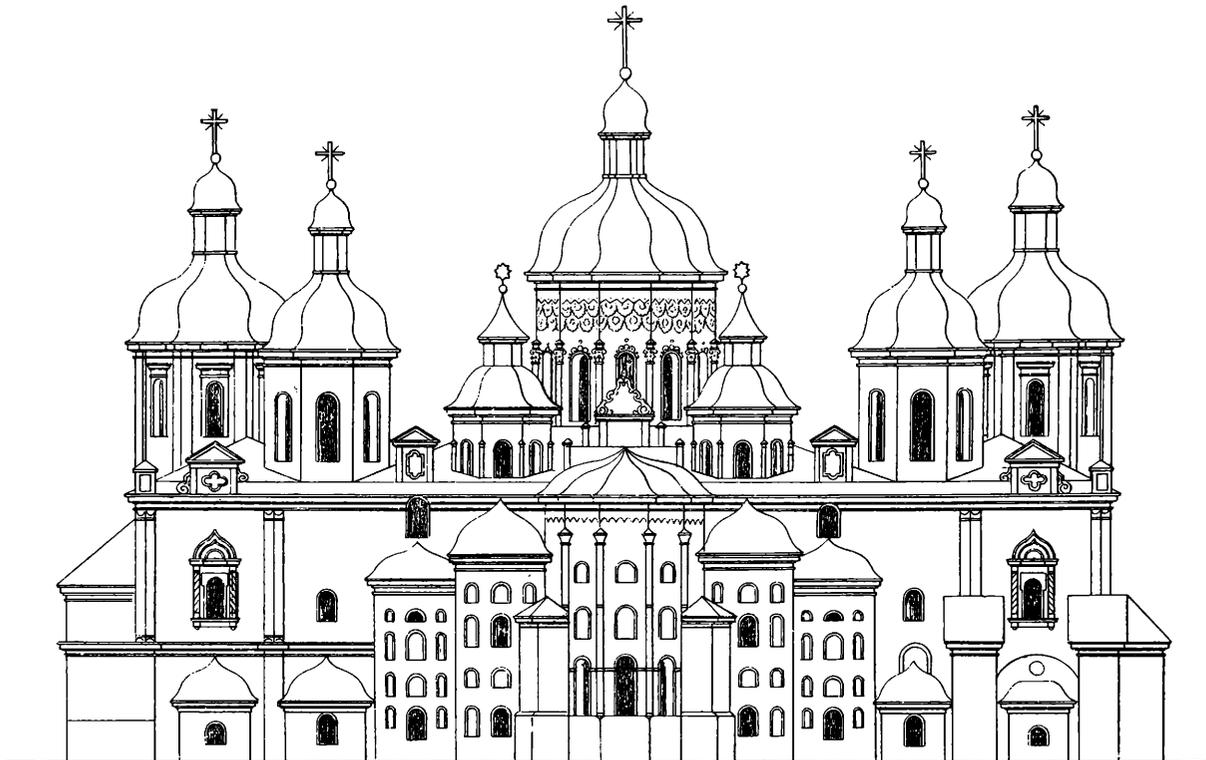
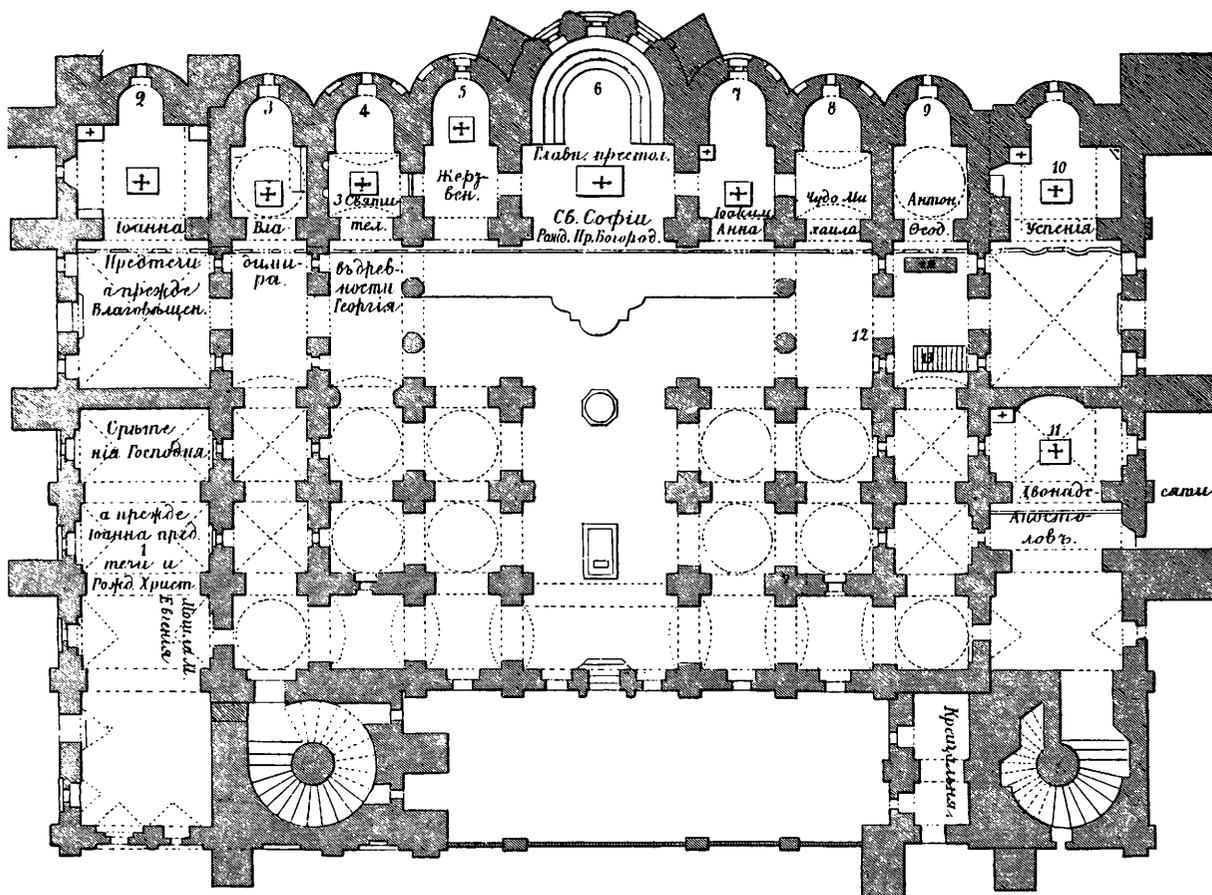
East façade and plan of the first floor by D. Ivanov (19th c.).
 Східня фасада і плян першого поверху за Д. Івановим (19 ст.).

The exact measurements for St. Sophia were made by the artist-architect D. Ivanov and the archeologist A. Ermolaev in 1810, long before the foundation in 1843 of the Committee for the Investigation of Antiquities. On the basis of these surveys, drawings of the plans, sections, and elevations of the cathedral were made. These valuable documents, as well as nineteen other drawings of Kievan monuments, were deposited in the Imperial Public Library of St. Petersburg. They were found there by N. Zakrevsky (1847) who used them in his publications.⁶⁰ Even more valuable than the latter was the monumental work of Academician F. Soltsev published in two luxurious large format atlases divided into four parts. They contain detailed measurements, careful drawings of frescoes and mosaics, diagrams of plans and sections, elevations and architectural details, as well as reconstructions of the original appearance of the cathedral.⁶¹

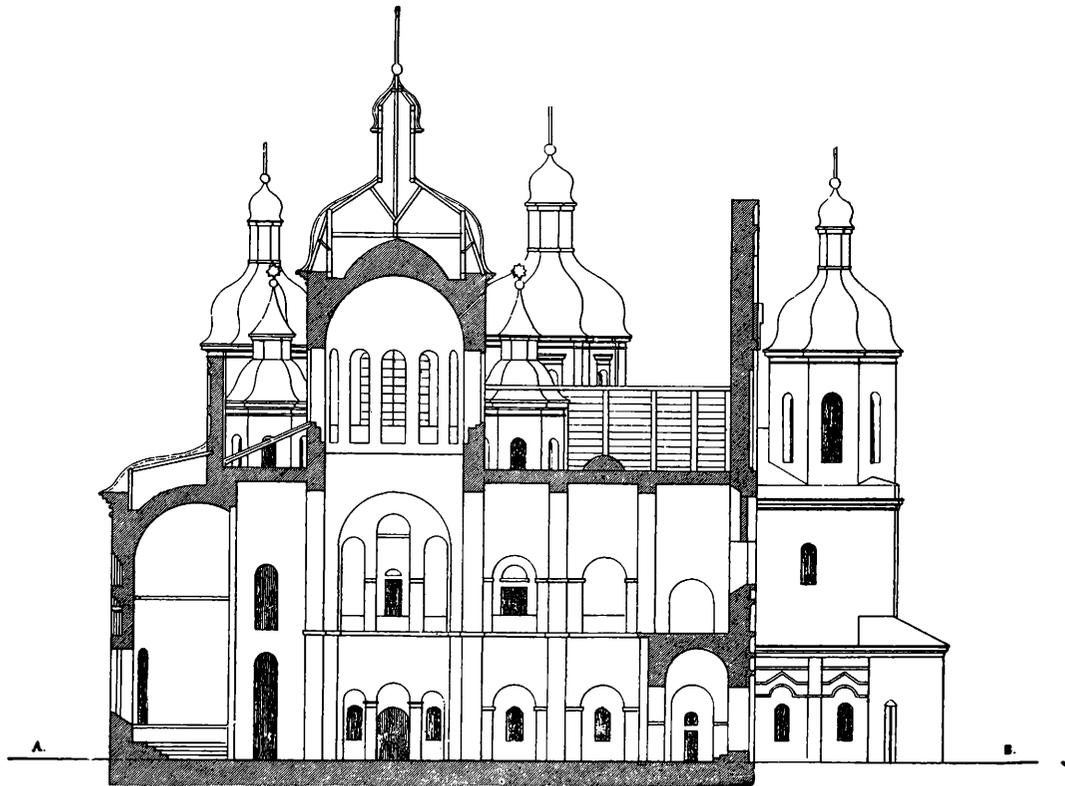
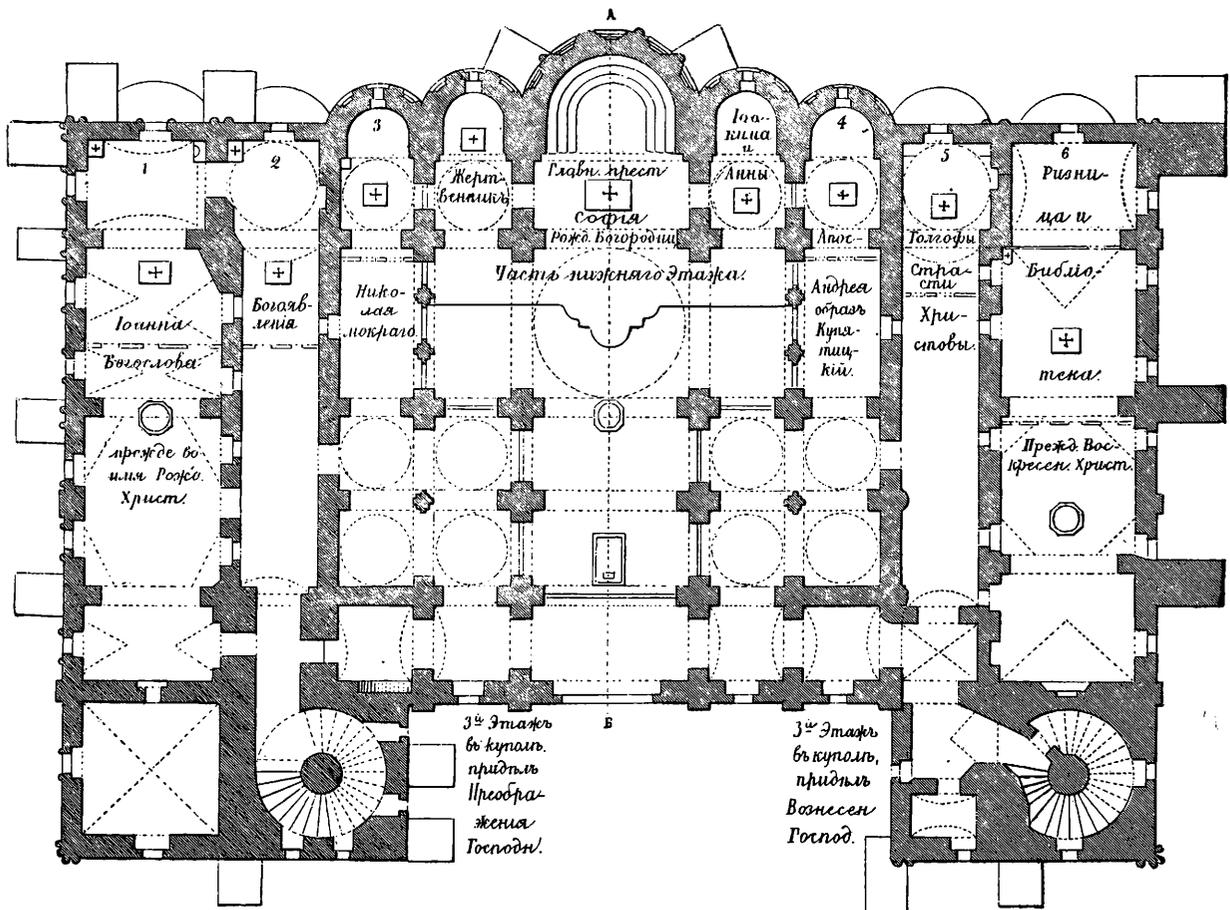
Cross-section and plan of second floor by D. Ivanov (19 c.).
 Розріз і плян другого поверху за Д. Івановим (19 ст.).

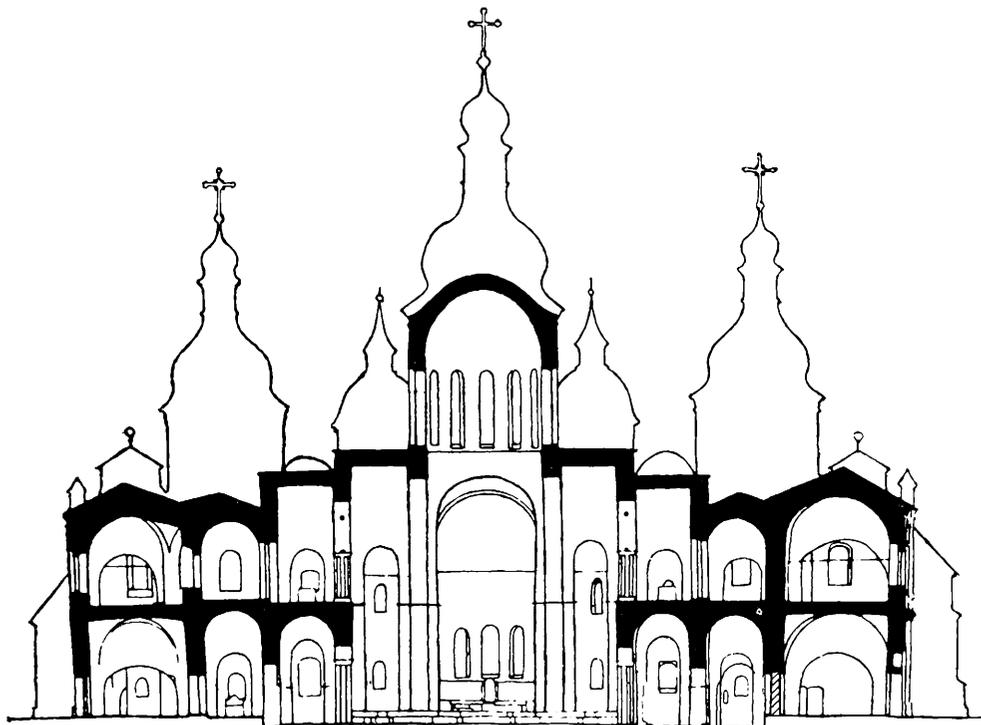
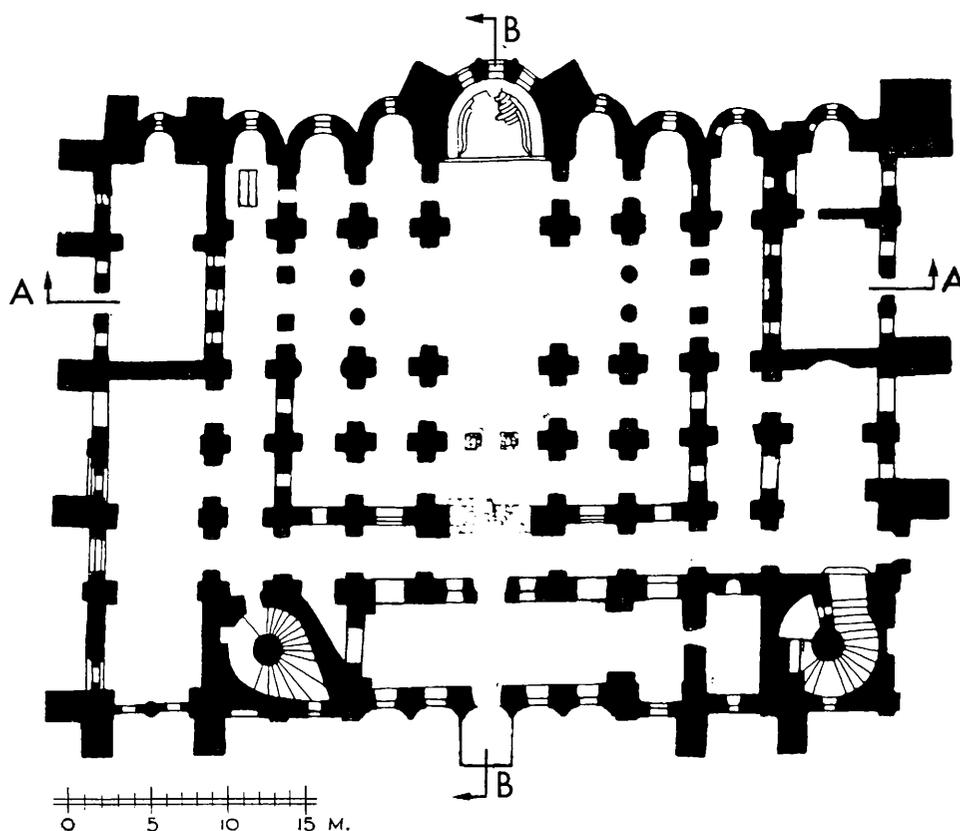
Section at A—A and first floor plan.
 (Measurements of Ukrainian Academy of Architecture).

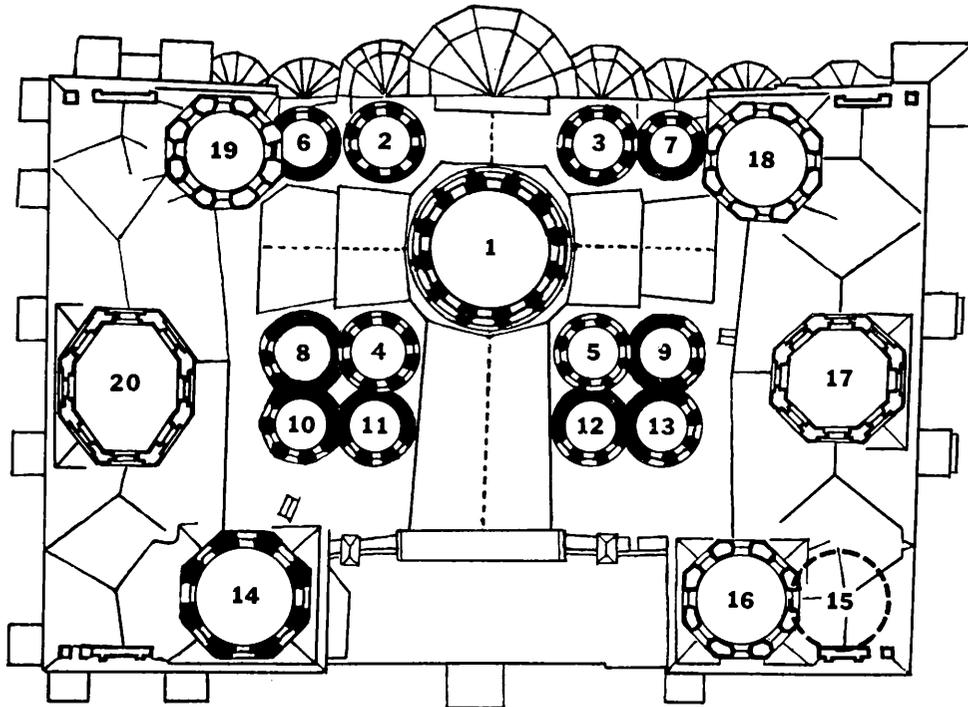
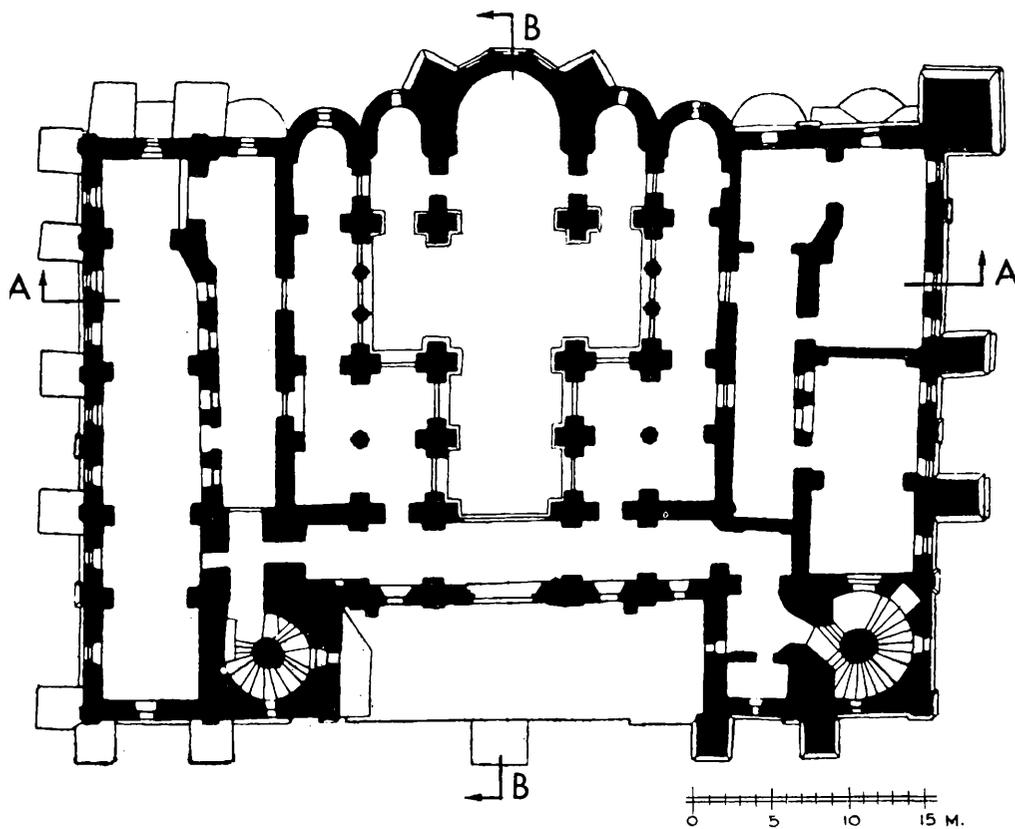
Roof and cupolas plan (above) showing: Nos. 1-13, 11th c. cupolas; 14, 11th c. tower; 15, top of tower (11-12th c.) was moved to present location; 16-20, cupolas of the end of 17th c. Second floor plan (below).

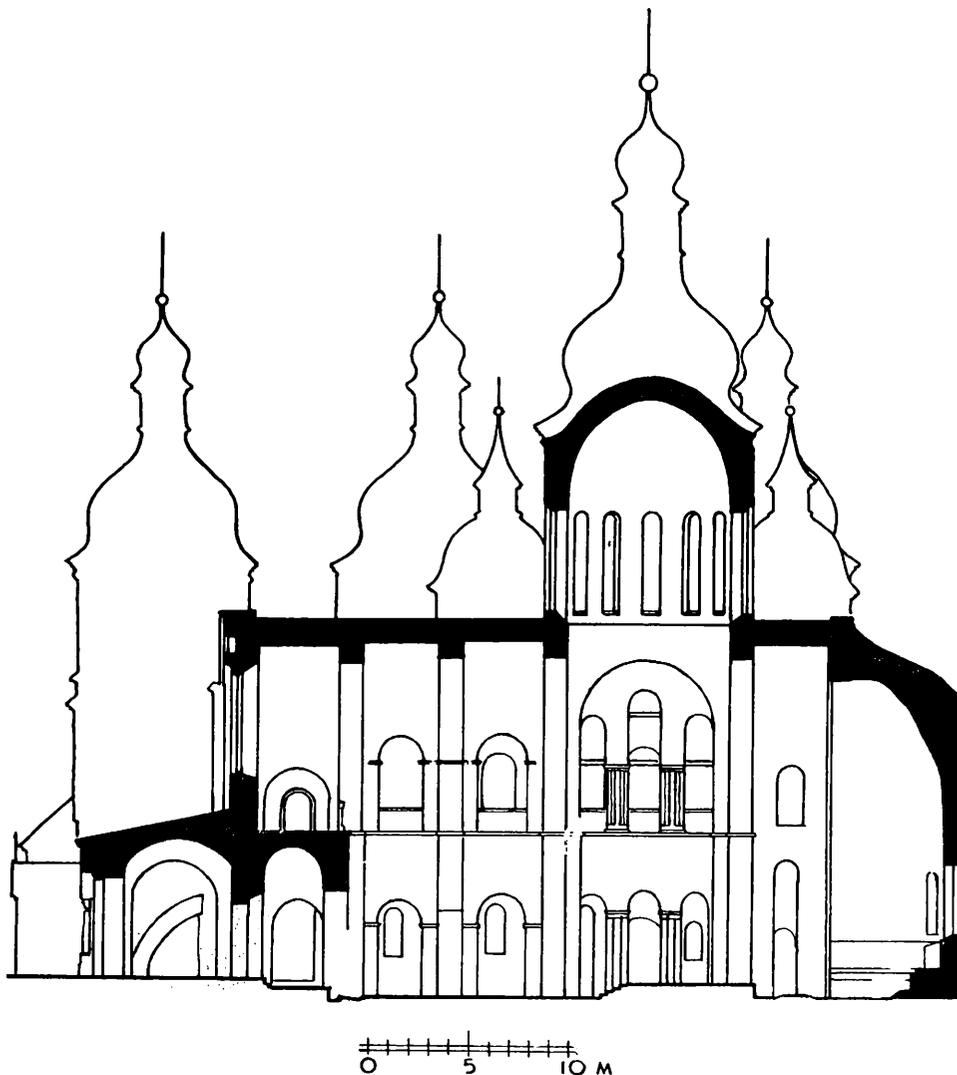
Section through main nave at B—B (see pp. 50, 51).

For source of plans (pp. 50, 51) and this section, see: S. Ya. Hrabovs'ky and Yu. S. Aseyev, "Doslidzhennya Sofiyi Kyuyivs'koyi," „Arkhitekturni pamyatnyky", zbirnyk nauk. prats', ed. S. Ya. Hrabovs'ky, (A.A. URSR, Kiev, 1950), pp. 32-41.

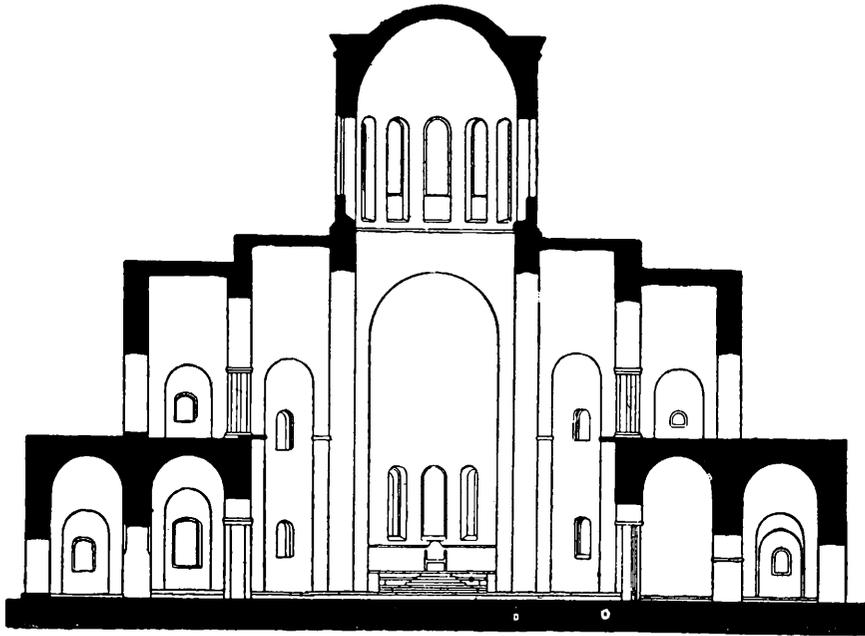
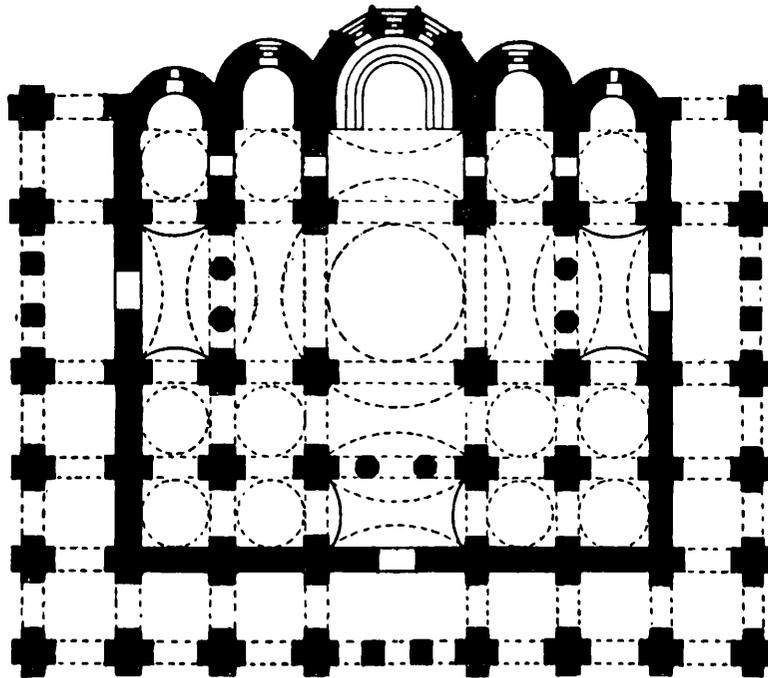
Plan and section of St. Sophia before the addition of the outside galleries. Reconstruction by Prof. N. Brunov.

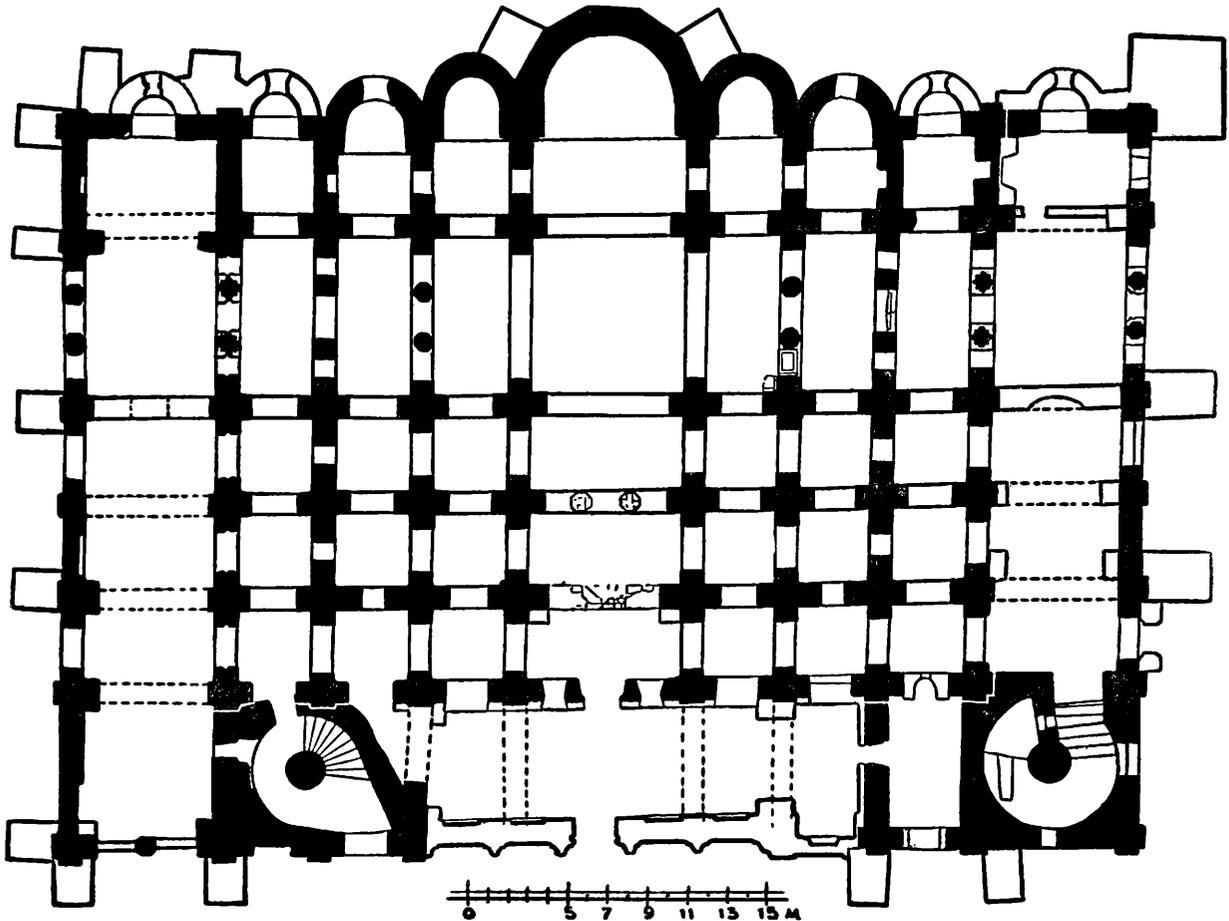
First floor plan by Prof. I. Morhilevs'ky.
Плян першого поверху. За проф. І. Моргілевським

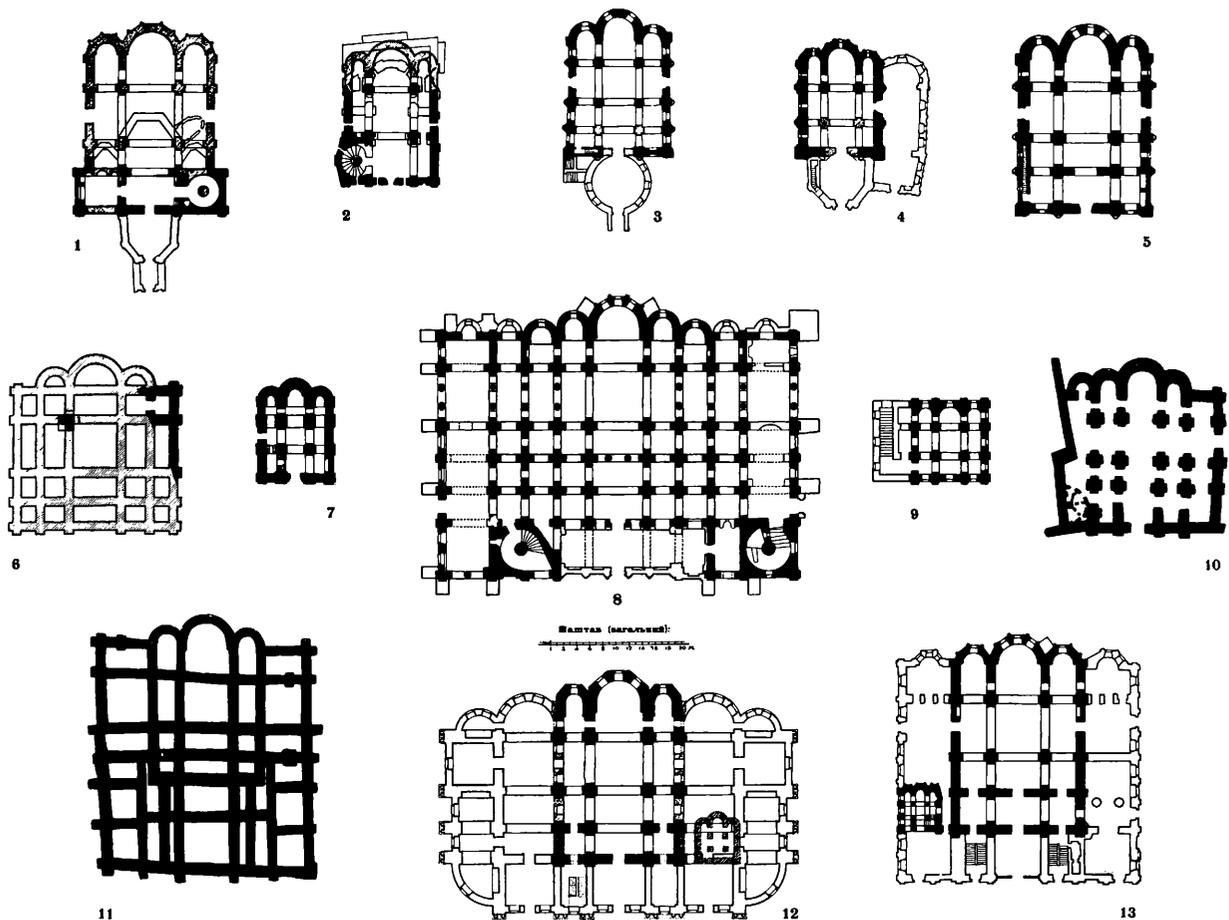
Comparative plans of the churches of Kiev, 10th—12th centuries, drawn on the same scale:

1. Church of the Redeemer in Berestovo, 12th c. 2. St. Michael Church of Vyduhets Monastery, 11th c.
3. Uspens'ka Church in Podil, 12th c. 4. Church of the Three Saints, 12th c. 5. Church of St. Cyril, 12th c.
6. Church of St. Irene, 11th c. 7. Church in Kudryavets, 12th c. 8. St. Sophia Cathedral, 11th c. 9. Trinity Church (Nadvoritnya), 12th c.
10. Church of St. George, 11th c. 11. Tithe Church (Desyatynna), 10th c. 12. The so-called Michael (formerly, Demetrius) Monastery, 11th c. 13. Uspens'ka Cathedral of the Kiev Pechers'ka Lavra (Monastery) 11th c.

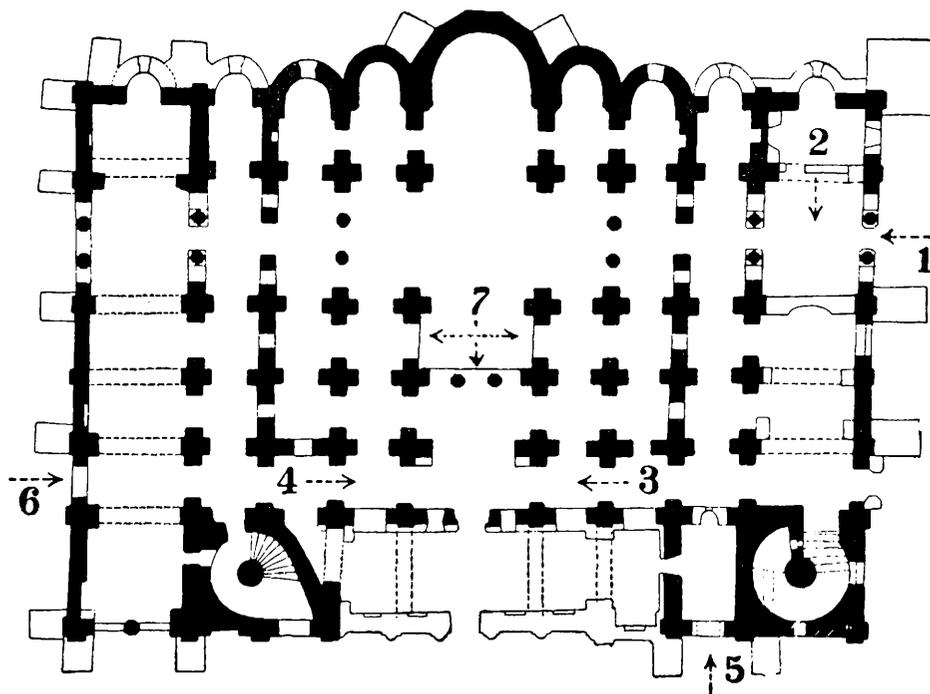
Key plan of the Cathedral with indications of positions from which Westervelt's drawings were made.

In order to orient the reader, a plan of the cathedral is given with approximate indications of the positions from which Westervelt made his drawings and the direction he was facing while making them. In the above case, the drawing was made from position 1. Today we see the following changes in this part of the church in addition to the erection of another story: All three open arches have been filled, a door cut into the immurement of the central arch, and windows cut into the immurements with the lateral ones. The niches over them have remained unchanged with the exception of the right one which is already half in ruins on Westervelt's picture. It has disappeared completely under subsequent layers of plaster. The left pilaster, clearly seen on Westervelt's drawing, was covered by a buttress in the 17th century. Next to the right pilaster and bordering the former triple arch, we see a window in the arch's immurement. It is also shown on Westervelt's drawing, but now it is much wider than in the 17th century. The remnants of the slate imposts of the arcade are visible even now from under the thick layer of plaster.

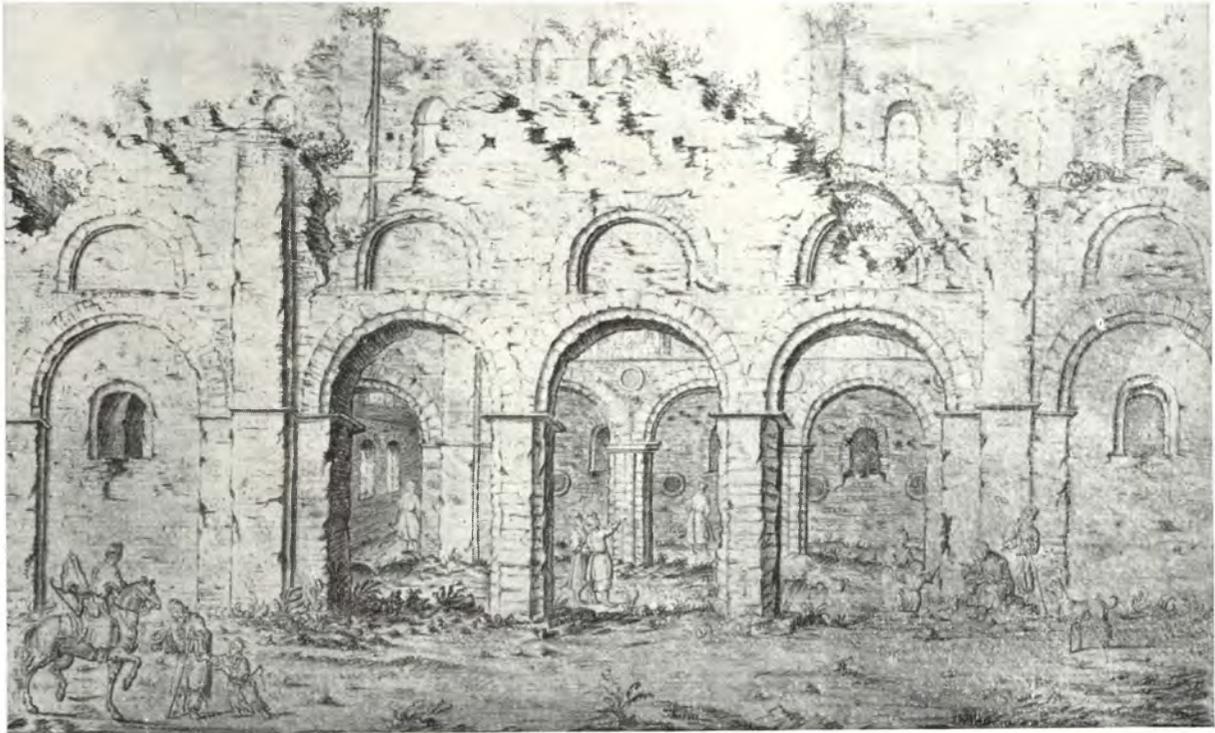
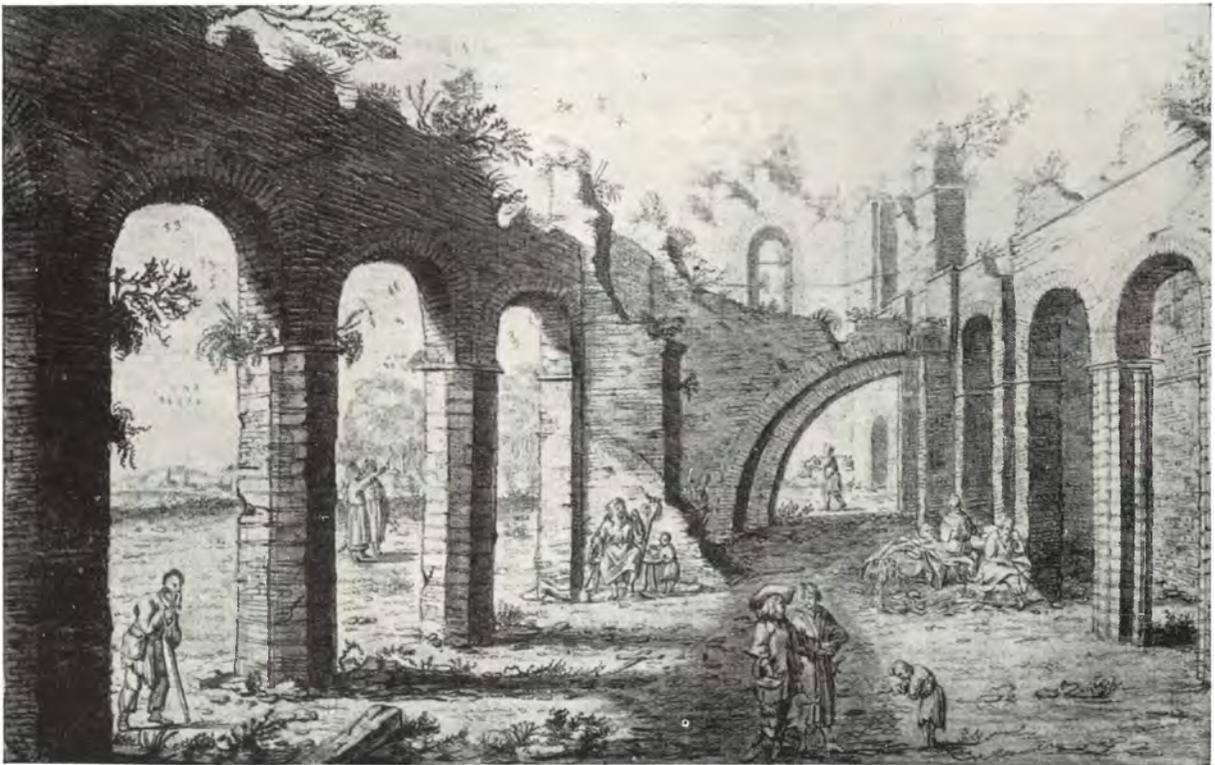
Southern gallery in 1651 after A. v. Westervelt's drawings; position 1, above, and position 2, below.
Південна галерія в 1651 р., за мал. А. Вестерфельда. Зверху: з 1-ої позиції; внизу: з 2-ої позиції.

On one of the drawings, bearing the inscription *Pars Academiae Kijoviensis versus Orientem*, Westervelt depicts the central portion of the southern external gallery of St. Sophia as having the form of a triple open arch supported by polygonal piers. Each arch is headed by a shallow niche composed of two receding rings. The arch is bordered on both sides by pilasters which are adjoined on either side by similar arches; these are filled rather than open and have a small window pierced in each immurement. In the clearance of the outer open arcade, still another is seen, which, however, is supported not by polygonal piers, as the first arcade, but by square ones with shafts along each of their corners. This drawing corresponds exactly to the part of the present southern wall where the entrance leads into the Dormition nave, and, therefore, should be considered as depicting the former southern external gallery.

On Westervelt's picture entitled *Pars Academiae Kijoviensis versus Occasum* (position 2), the same part of the outer gallery is shown but this time from the inside. Facing west (i.e., in the direction of the shaft at position 2 of the plan) we see, to the left, the same triple arch supported by polygonal piers (discussed with reference to the previous drawing) and, to the right, the internal arcade resting on square piers adorned with shafts (seen in the clearance of the outer arcade on the previous drawing by Westervelt). Straight ahead we see two parallel flying buttresses which abut into two neighboring transverse partitions. The third buttress, nearest to us, which supported the transverse wall immediately behind the arcade, is in ruins; only its springing remains visible on the drawing. Today a wall with a small apse (see plan) replaces this ruined flying buttress. It divides the Dormition nave from the nave of the Twelve Apostles. In the clearance of the flying buttresses the drawing shows the

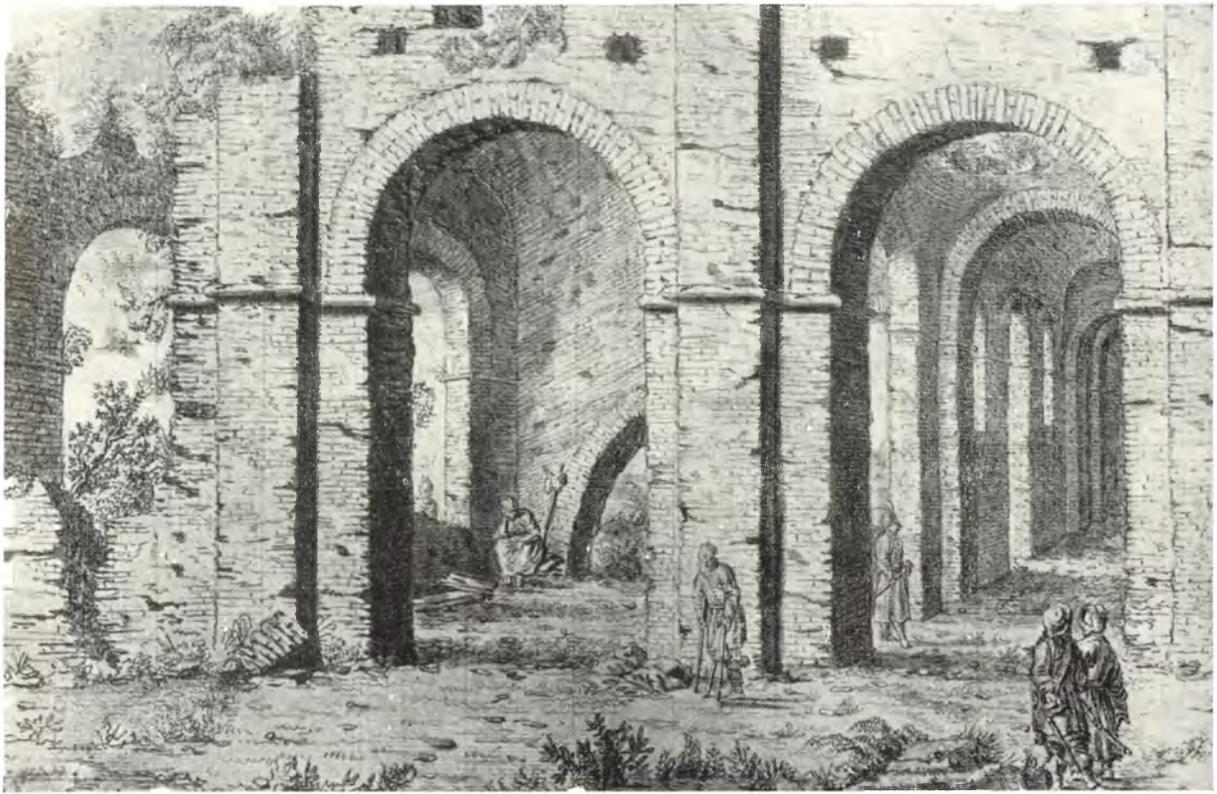
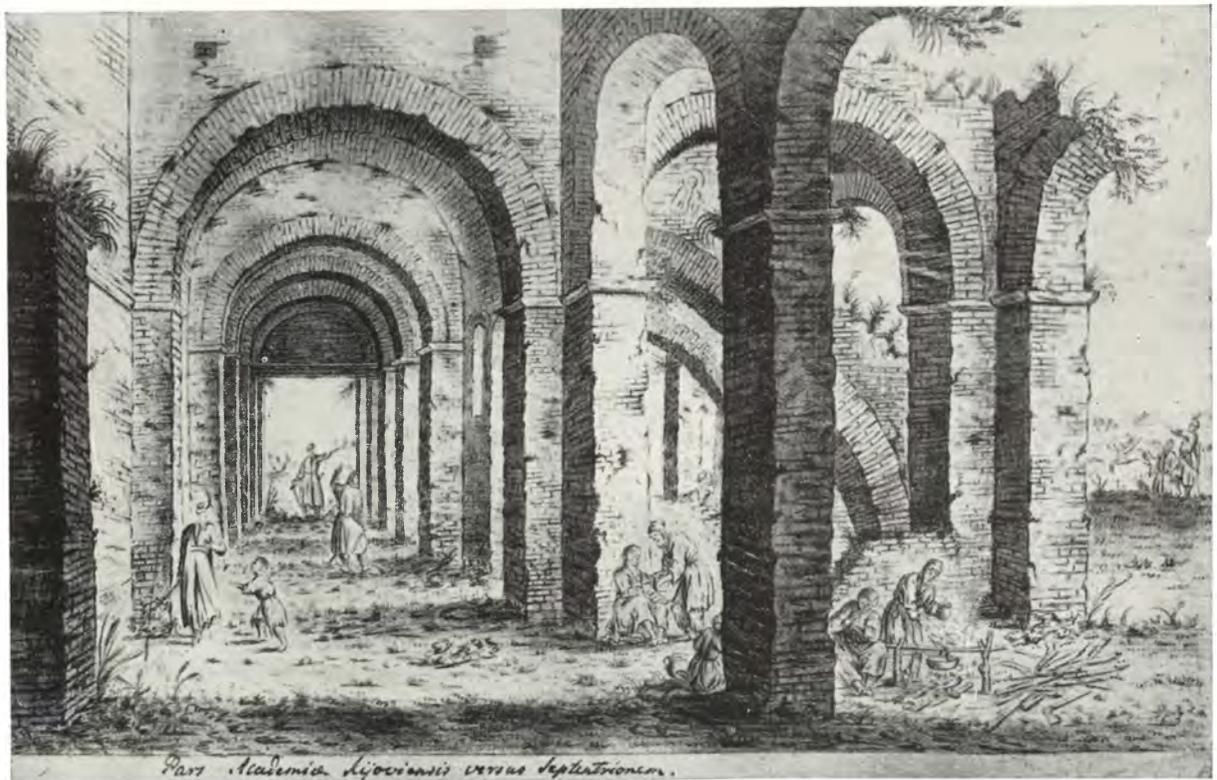
Western galleries in 1651 after A. v. Westervelt's drawings; position 3, above, and position 4, below.
Західні галерії в 1651 р., за мал. А. Вестерфельда. Зверху: з 3-ої позиції; внизу: з 4-ої позиції.

Westervelt's drawing numbered 313 (position 3) depicts the lower part of the western interior gallery and a section of the adjoining outer gallery in the direction south-north. The left part of the drawing, representing the outer arcade, does not quite correspond to reality. Nevertheless, one can distinguish corresponding parts of this section of the church, which are still extant, namely, the flying buttress of the outer arcade, situated directly south of the main entrance, and the main entrance itself (which in the 17th century led from the open outer arcade and now leads from the narthex) with windows on either side. Furthermore, one sees the pilasters on each side of the main entrance, which correspond to the arrangement of the cross-shaped piers in the neighboring lateral naves, and, finally, the arch embrasure in front of the SS. Joachim and Anna nave. At present there is a window in this embrasure. Professor Morhilevs'ky thinks that this drawing of Westervelt also includes the baptistry,⁶⁸ with the corresponding part of the arcade open. Later it was walled up and now a small window has been set into the wall. Thus, in the position from which the drawing was made the baptistry could be seen.

The drawing entitled *Pars Academiae Kijoviensis versus Septentrionem* (position 4) represents the same lower part of the internal gallery and the neighboring outer gallery but viewed from the opposite direction (north-south). Here one clearly recognizes the main western entrance, the open entrance to the internal gallery leading from the south (a man is standing in its clearance), and the vaulted ceiling supported by the cross-shaped piers which also support the arches. Slate cornices and arch imposts also appear very distinctly. On the right side of the drawing one sees a fairly exact rendition of the external gallery with its pylons, flying buttresses, arches, and vaults.

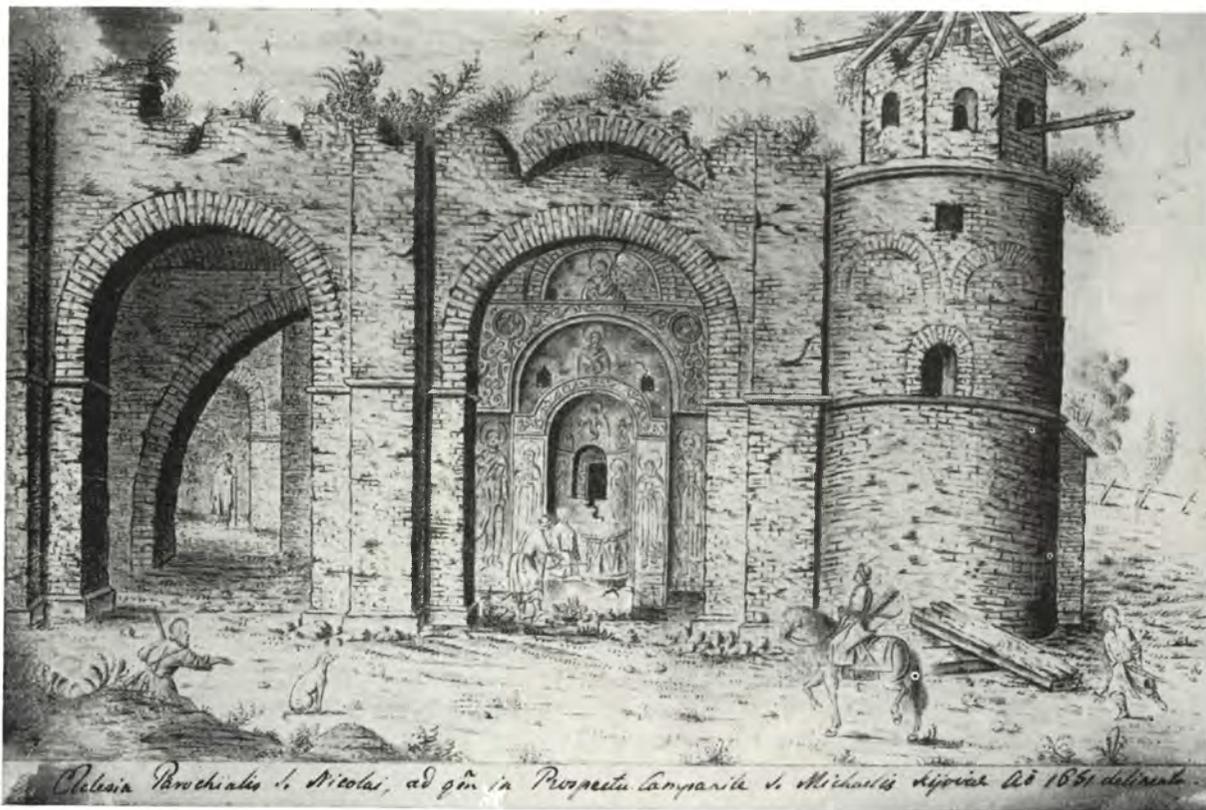
Southwestern part of the Cathedral. Position 5 of Westervelt's drawing, 1651.
 Південнозахідня частина катедри за мал. Вестерфельда 1651 р. (Позиція 5).

Westervelt's drawing with the subtitle *Ecclesia Parochialis S. Nicholai, ad quam in Prospectu Campanile S. Michaelis Kijoviae Anno 1651 delineata* (position 5) is very interesting, but its right half difficult to interpret. It depicts the southwestern corner of the cathedral. The middle part of the picture, showing the baptistry through the aperture of the arch, is painstakingly exact. With almost photographic accuracy, the painter represented the 11th century frescoes of the baptistry and the immurement of the 12th century arch with its small apse and lunettes,

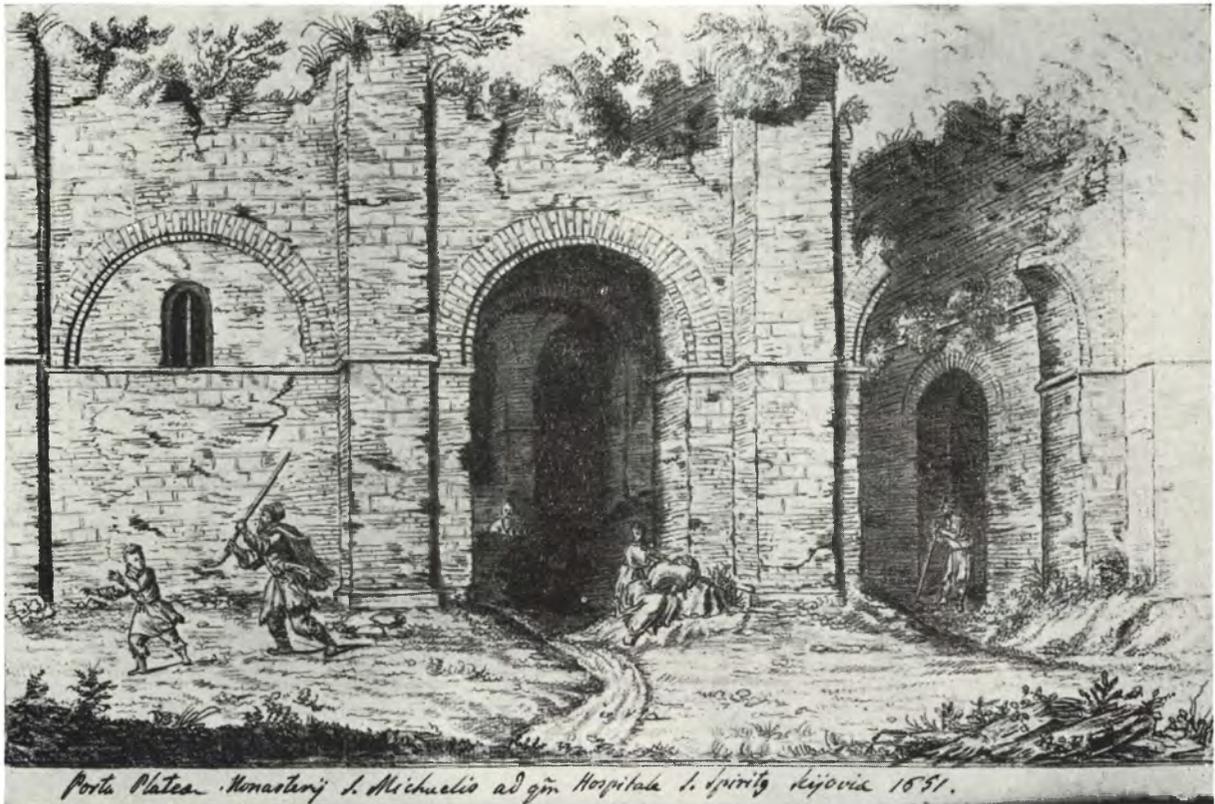
Part of northern façade. Position 6 of Westervelt's drawing, 1651.
Частина північної фасади катедри. Мал. Вестерфельда, (позиція 6), 1651.

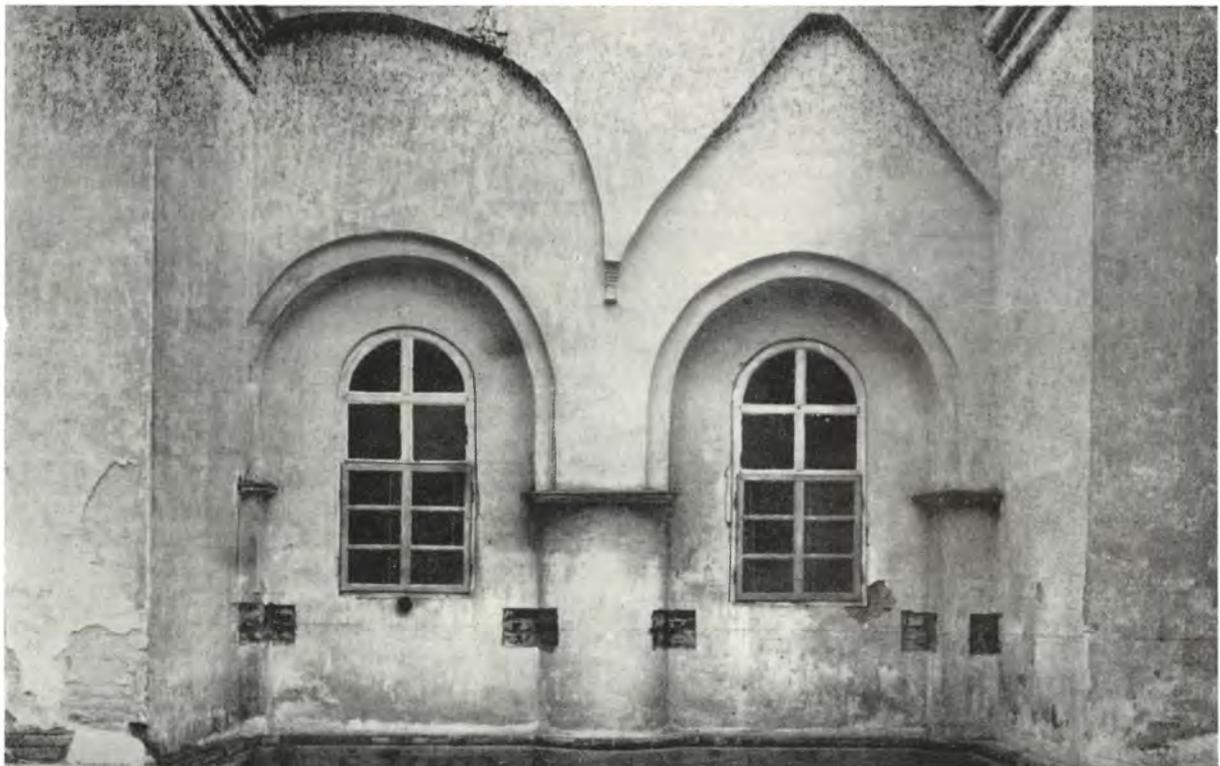
The walled-in gallery of the western façade at the present time.
Деталь замуrowаної галерії західної фасади — сучасний стан.

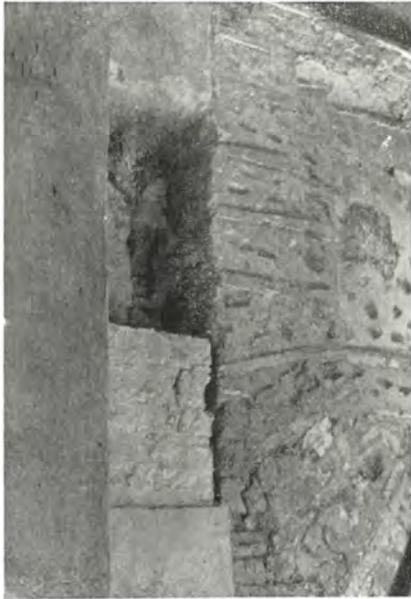
Joint between 11th and 12th cent.
wall after the removal of plaster.

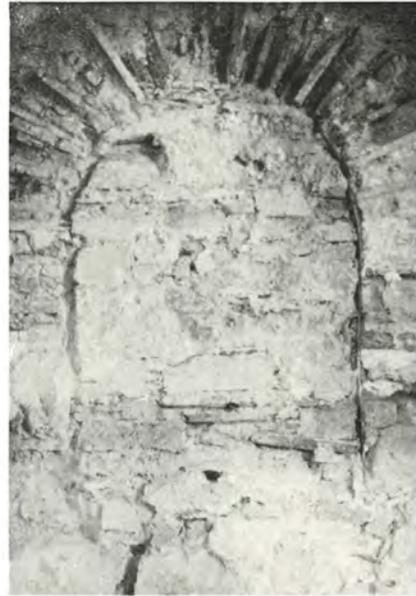
Masonry of a decorative niche of
the 11th c. after removal of plaster.

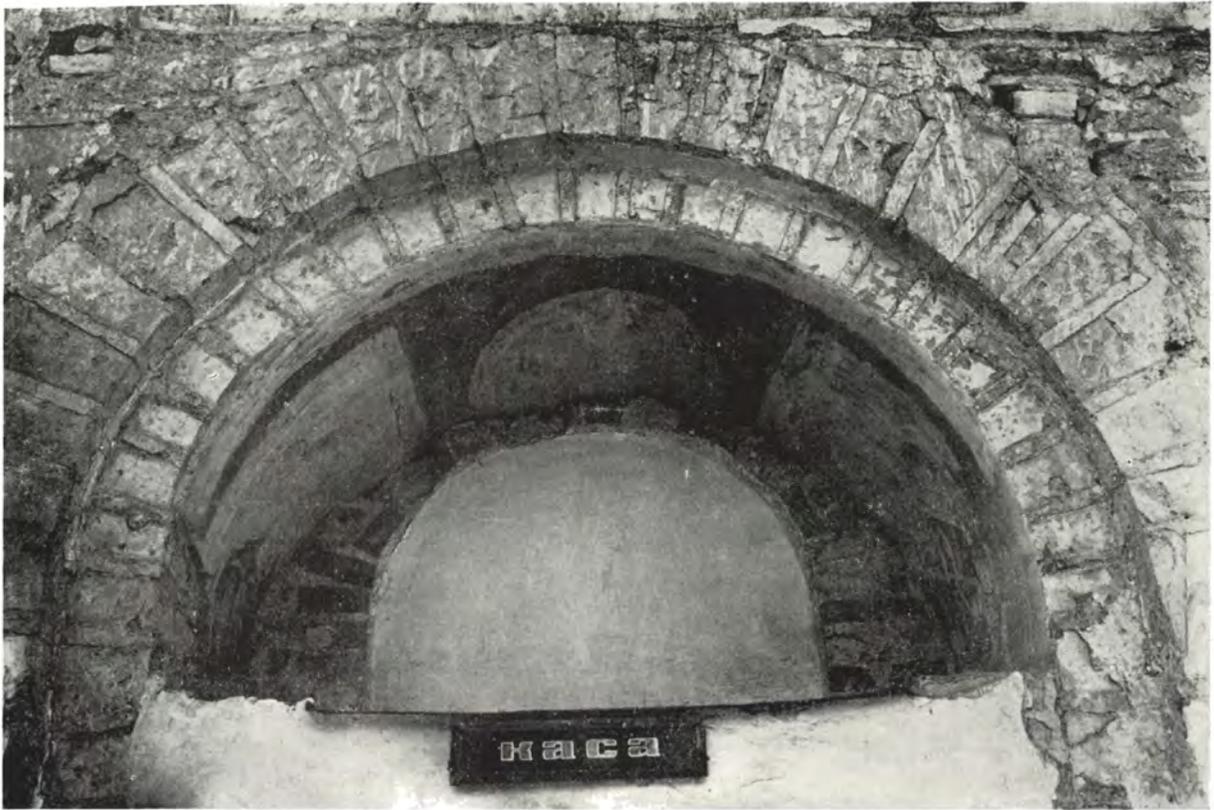
Niche with plaster removed — southern façade.
Очищена від тинку ніша південної фасади.
