SURVEYS, ATTEMPTS AT RESTORATION, AND INVESTIGATIONS OF THE ARCHITECTURE OF THE CATHEDRAL OF ST. SOPHIA

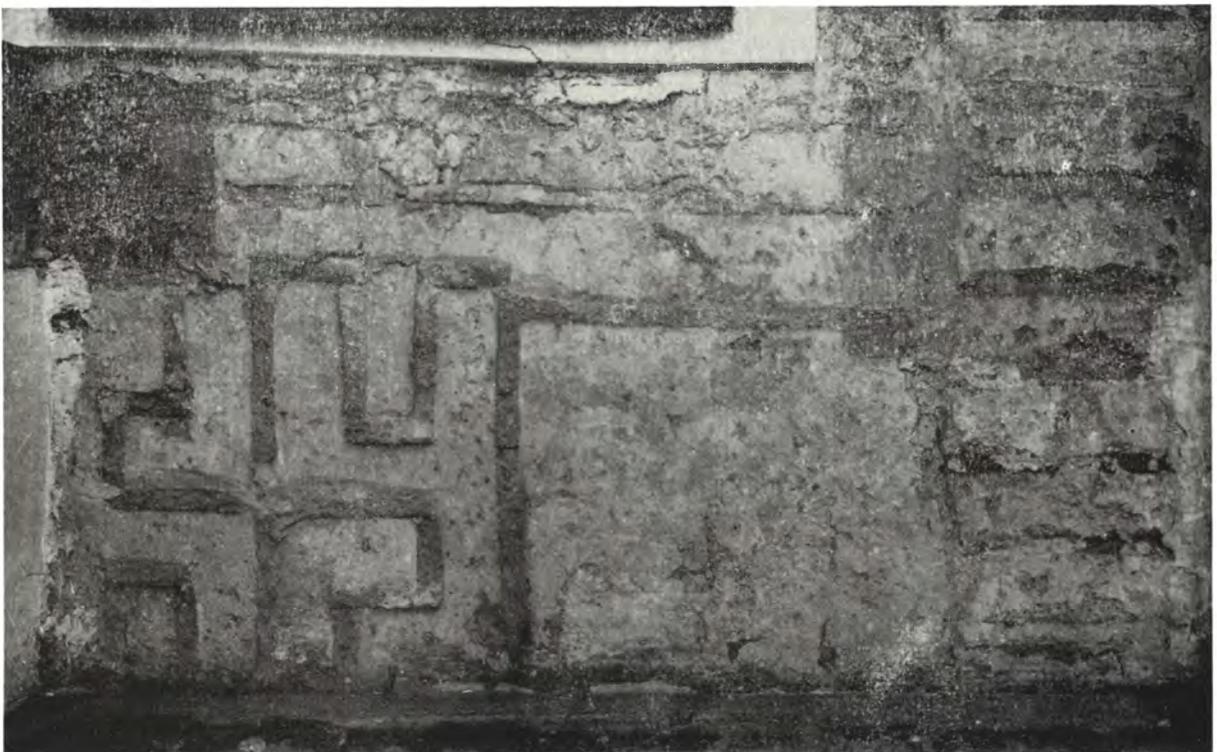
Meander design on masonry — northern façade.
Меандер, виложений з цегли на стіні північної фасади.

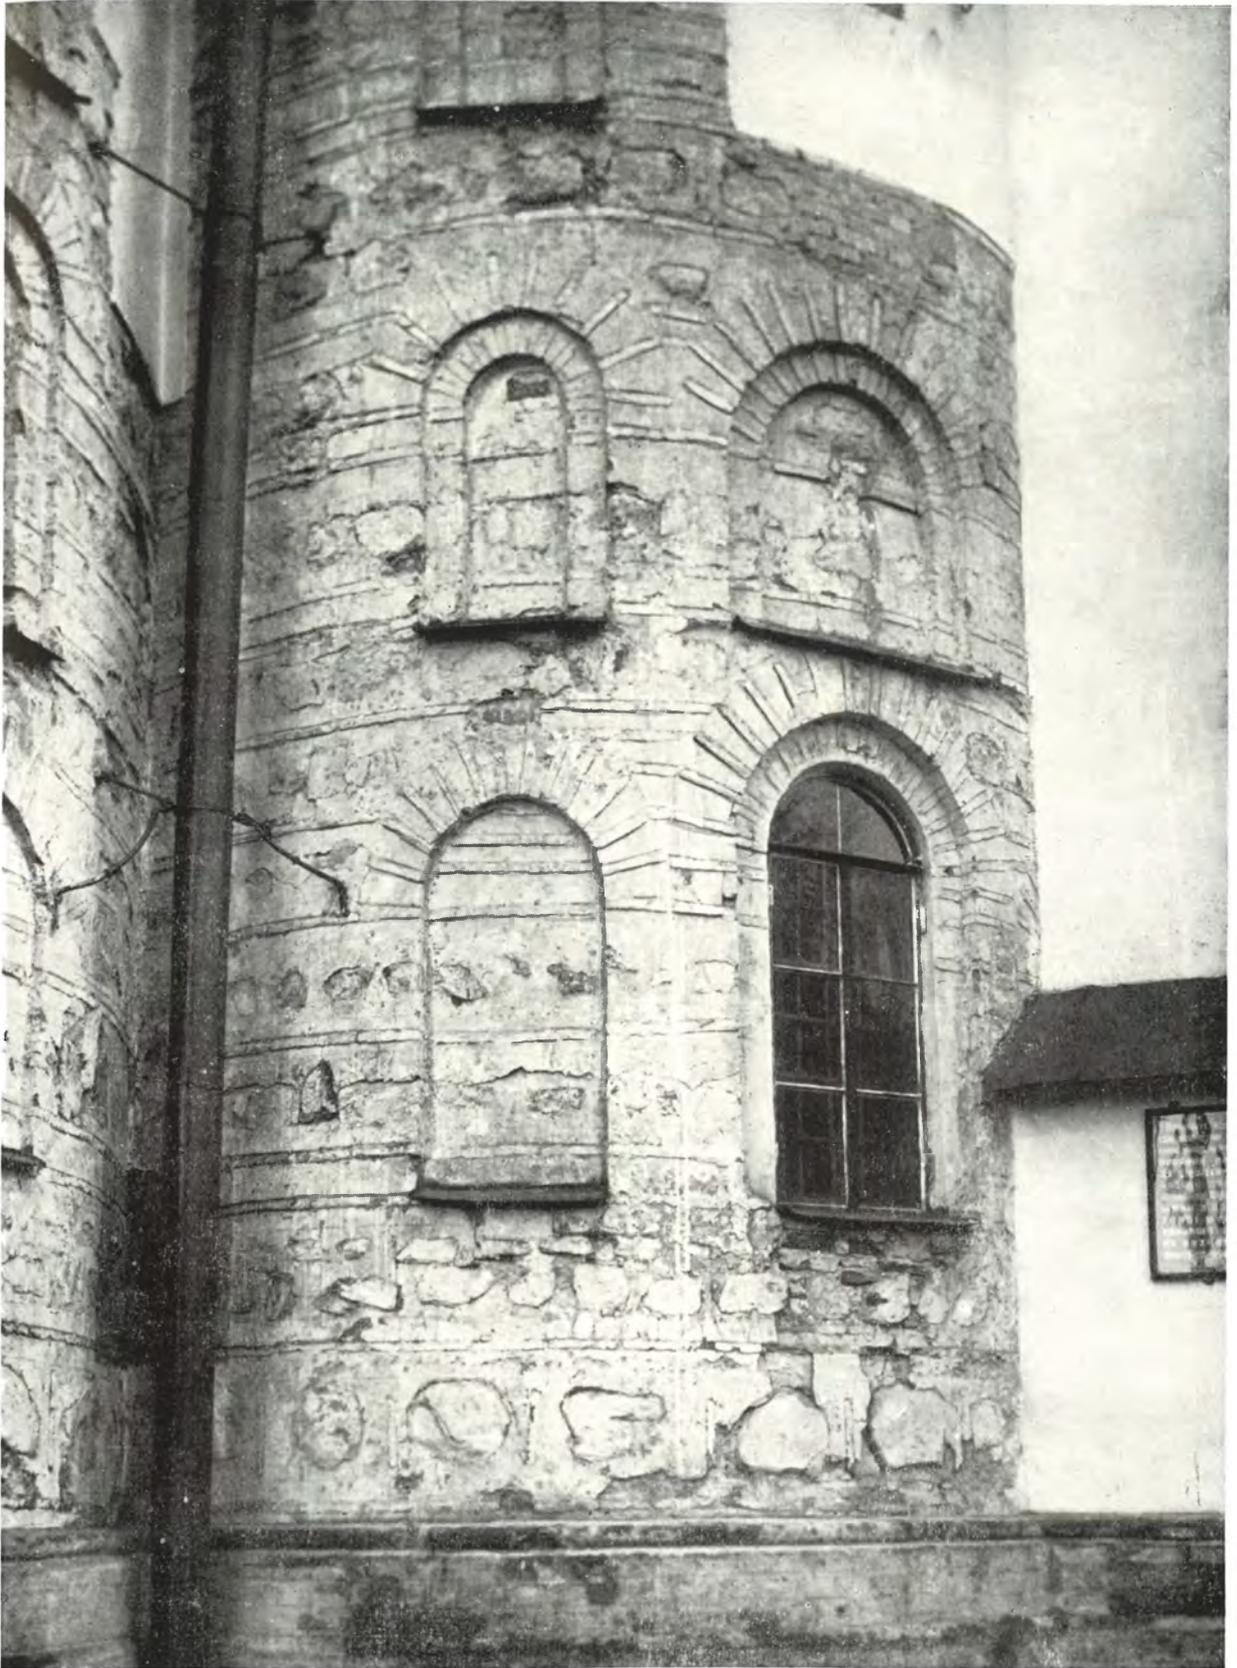
Exterior wall with plaster removed — altar of SS. Joachim and Anna.
Очищена від тинку апсида вітваря свв. Якима і Ганни.

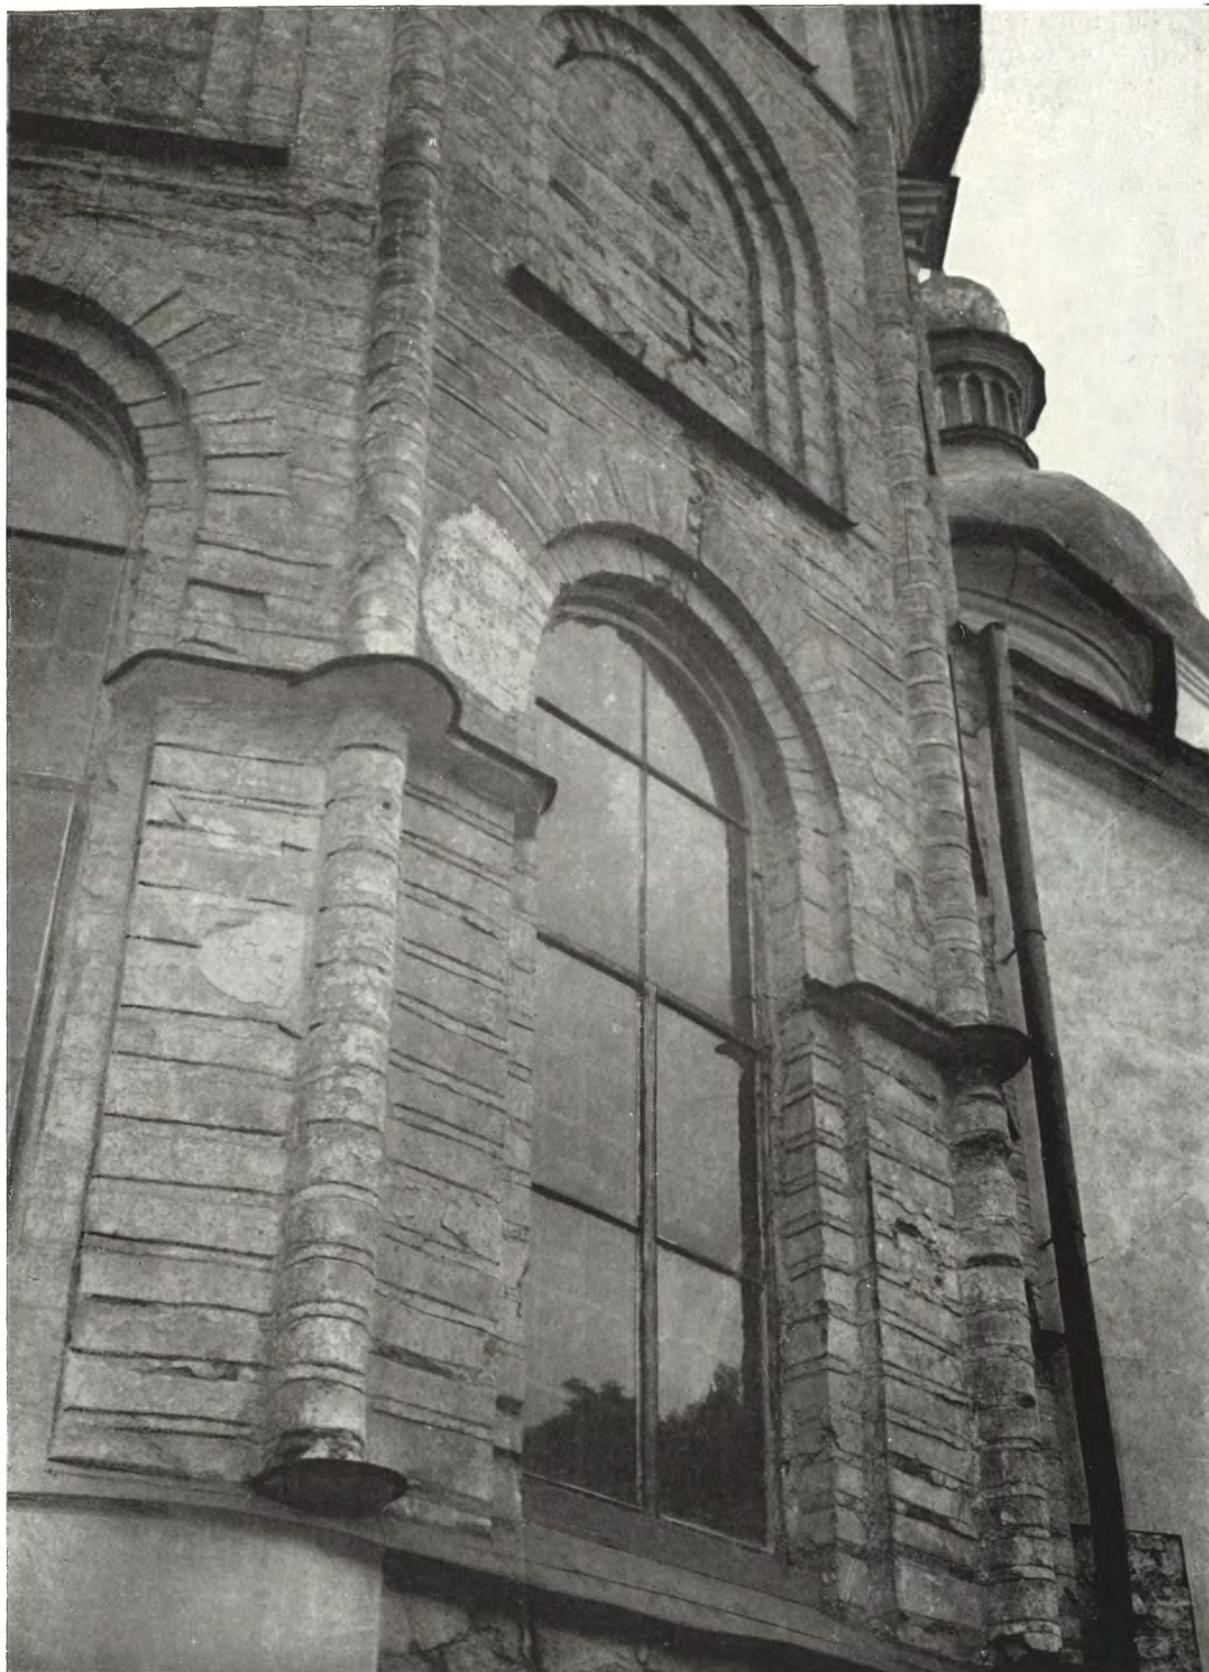
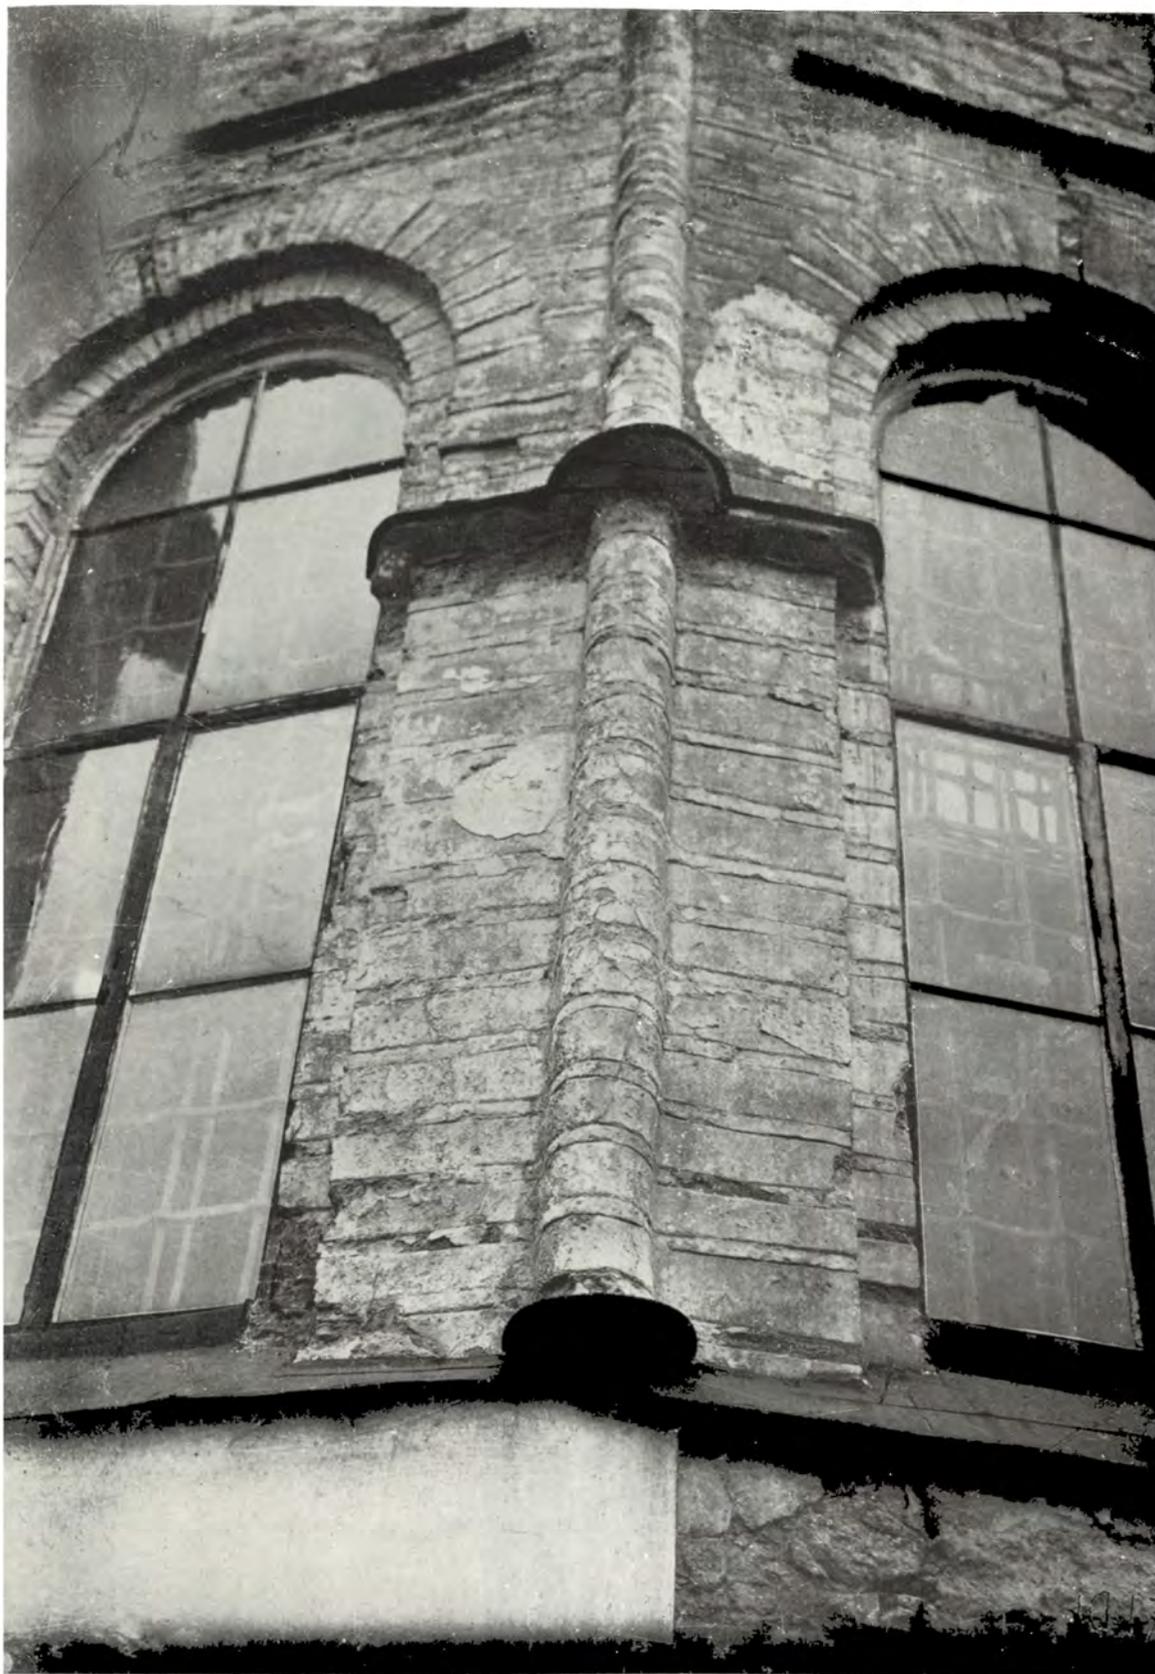
Exterior walls with plaster removed — main apse.
Стіни головної апсиди після очищення їх від тинку.

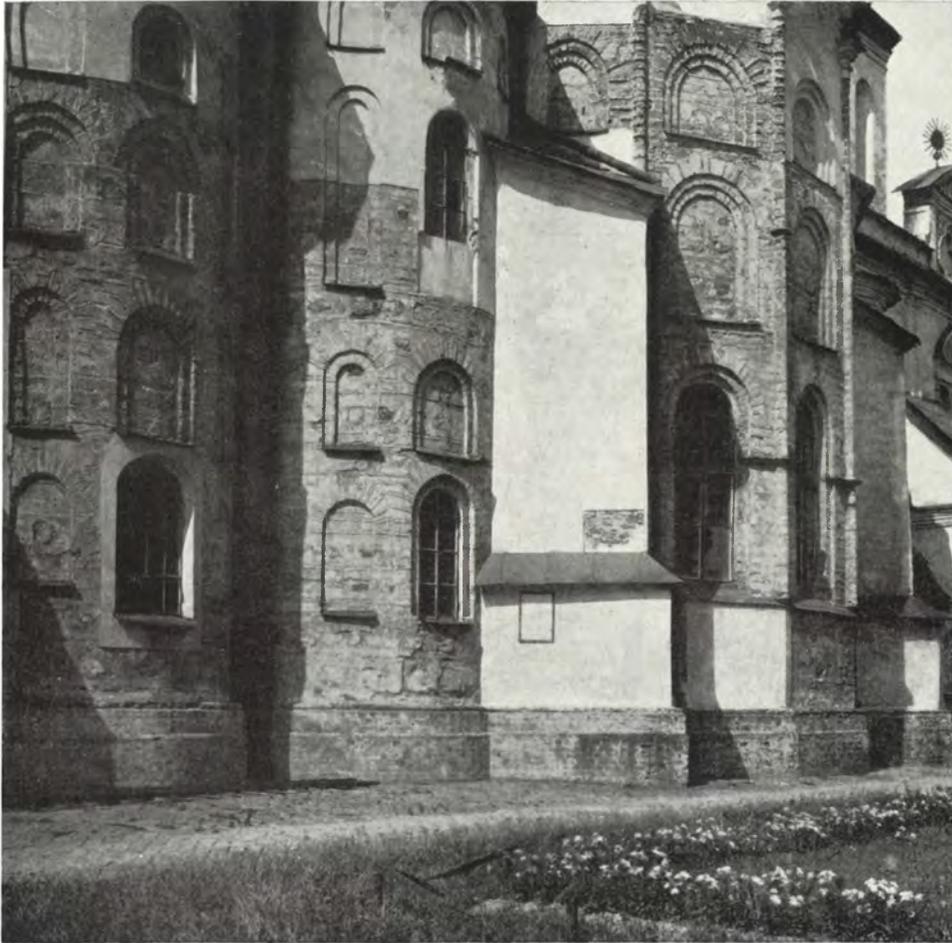
Exterior wall with plaster removed — eastern façade.
Східня фасада після очищення від тинку.

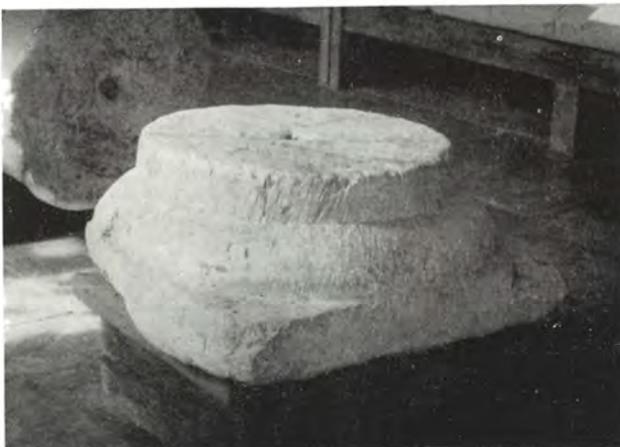
Detail of marble base of column
of portal—main western entrance.

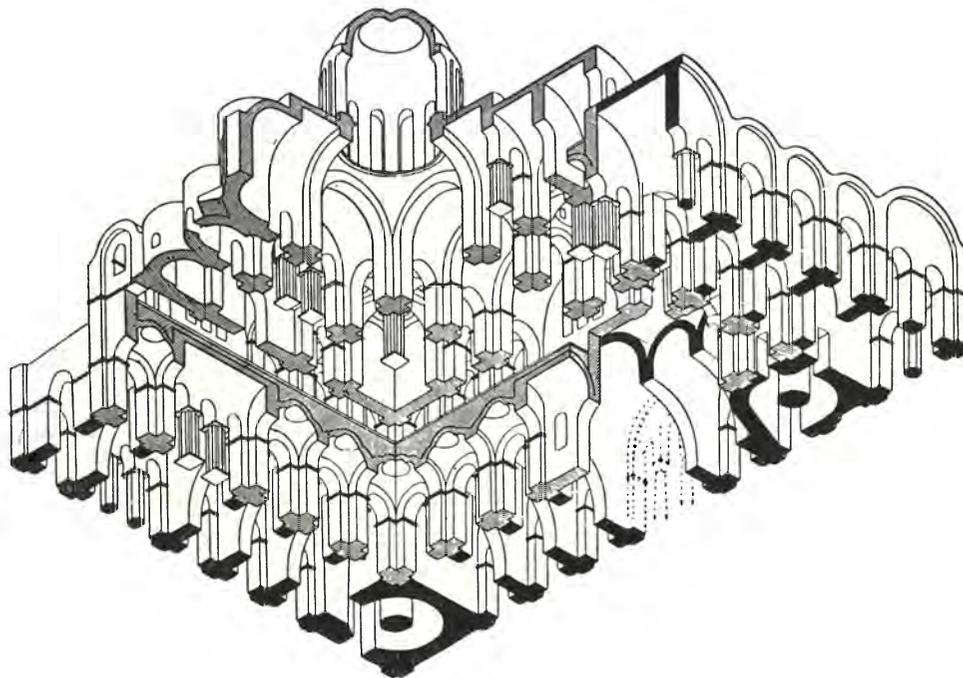
Isometric restoration (by Prof. I. Morhilevs'ky).
 Аксонометрична реконструкція проф. І. Моргілевського.

work repeatedly quoted here, deserves special attention.⁷⁴ N. Brunov in his article "On the Question of the Independent Features of Russian Architecture"⁷⁵ also publishes the isometric section of Morhilevs'ky but disagrees with him on the following two points concerning his concept of the earliest part of the cathedral: (1) The western arm of the cross is shown in the section in its present form which is actually the result of basic alterations made between the 17th and the 19th centuries. (2) The gallery girdling the five-nave central area and belonging to the original building is shown as open in its lower story and is composed of cross-shaped pillars supporting arches; the upper story of the gallery is walled in, with windows cut into the walls, and has a vaulted ceiling. In reality, says Brunov, the piers and vaulting of the ground floor bore an open exterior arcade built level with the cathedral's choirs and bordered by a low parapet.⁷⁶ Brunov, while justly remarking that Morhilevs'ky's isometric

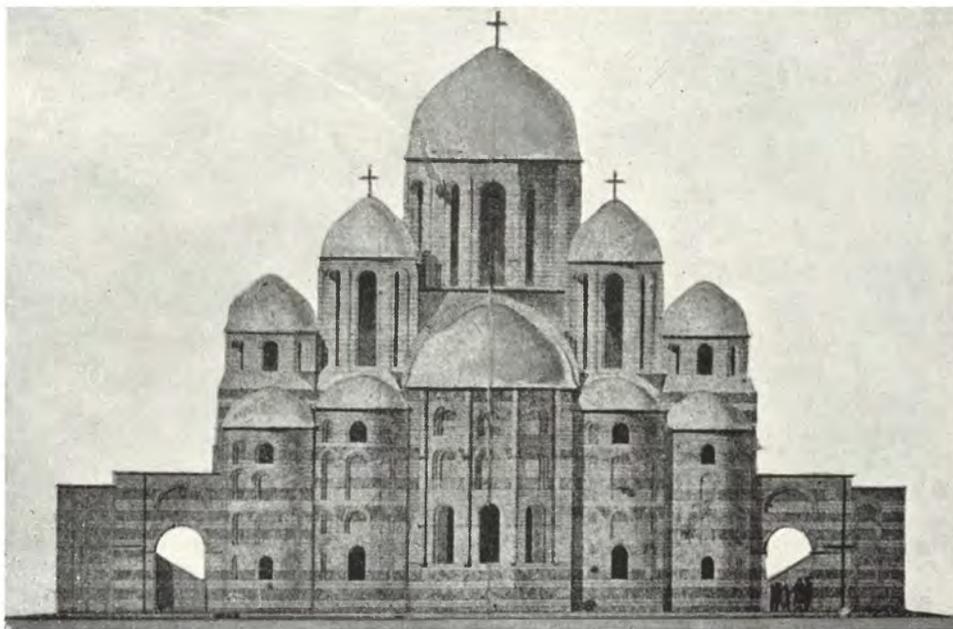
Front view of eastern elevation. Restoration
by Academician F. Solntsev, 19th century.
Східня фасада катедри. Реконструкція акад. Ф. Солнцева, 19 ст.

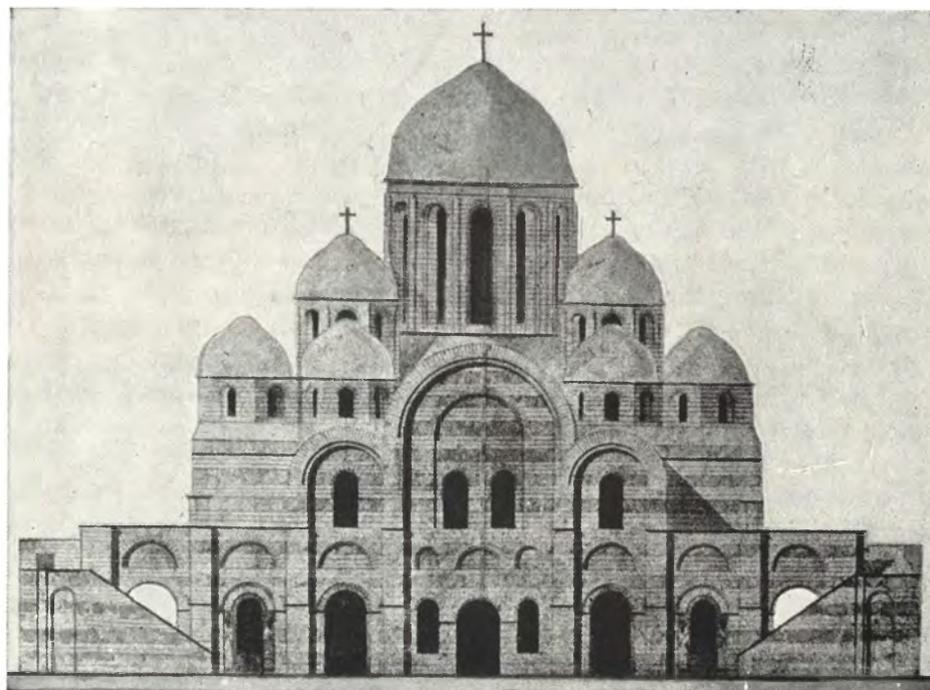
Front view of western elevation. Restoration
by Academician F. Solntsev, 19th century.
Західня фасада катедри. Реконструкція акад. Ф. Солнцева, 19 ст.

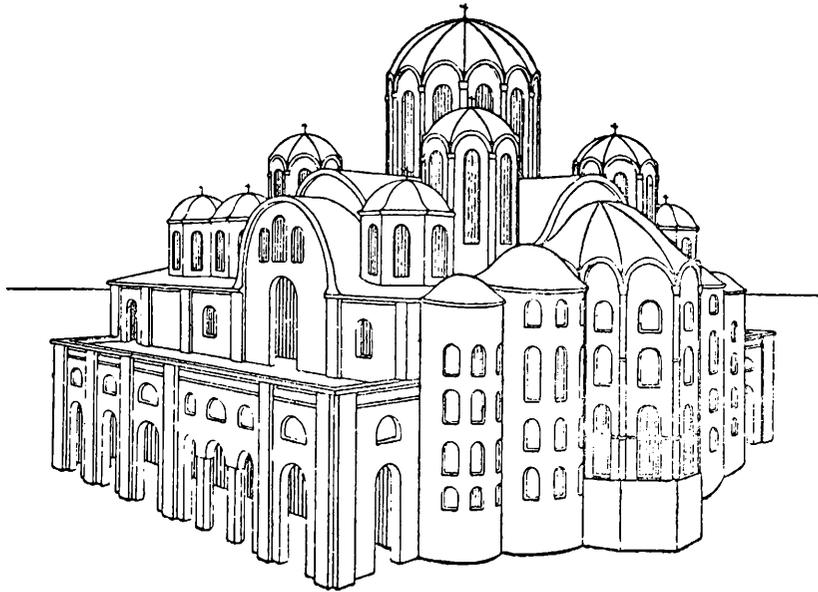
General view of Cathedral before addition of outside galleries.
Restoration by Academician O. Novyts'ky.
Загальний вид катедрі перед добудовою зовнішніх галерій.
Реконструкція акад. О. Новицького.

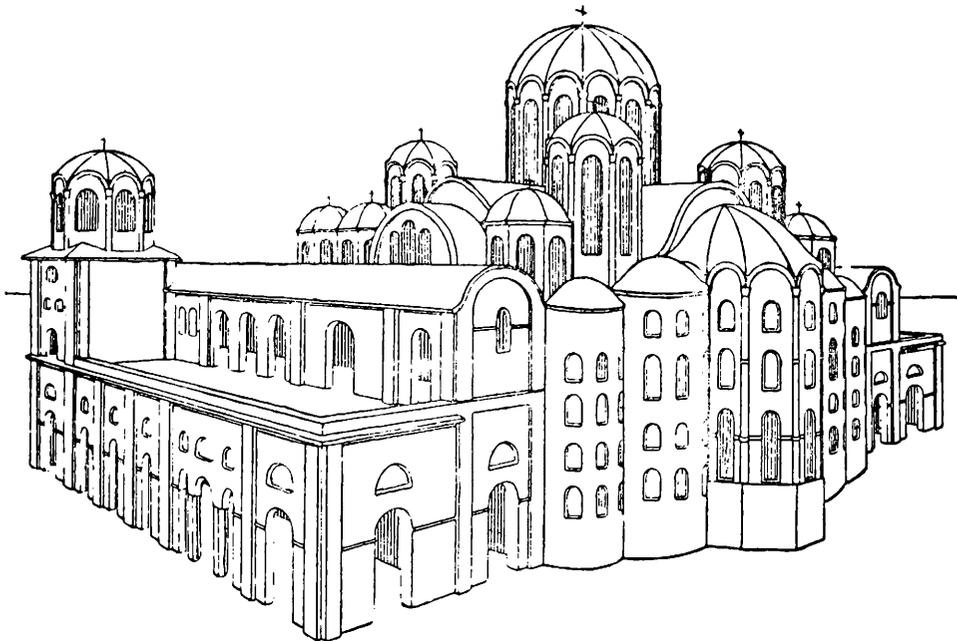
General view of Cathedral after addition of outside galleries and southwestern tower. Restoration by Academician O. Novyts'ky.
Загальний вигляд катедрі з добудованими зовнішніми галеріями й південнозахідньою вежою. Реконструкція акад. О. Новицького.

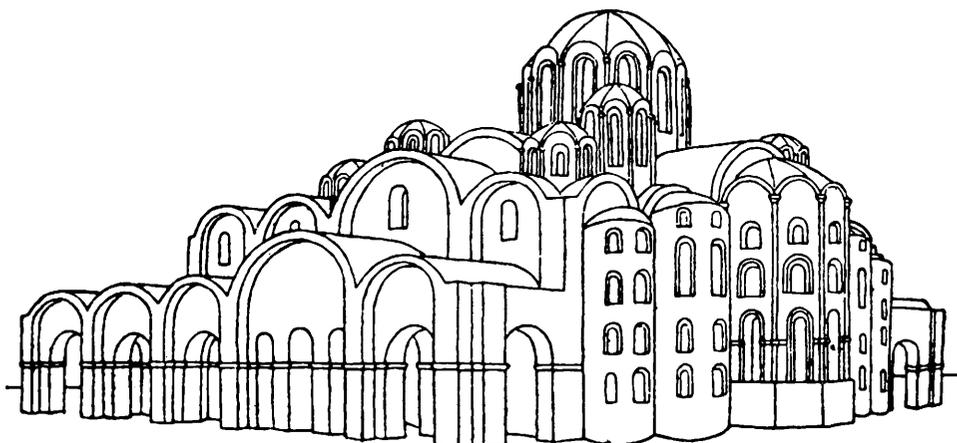
General view of Cathedral, restoration by Professor A. Nekrasov.
 Загальний вигляд катедрі. Реконструкція проф. А. Некрасова.

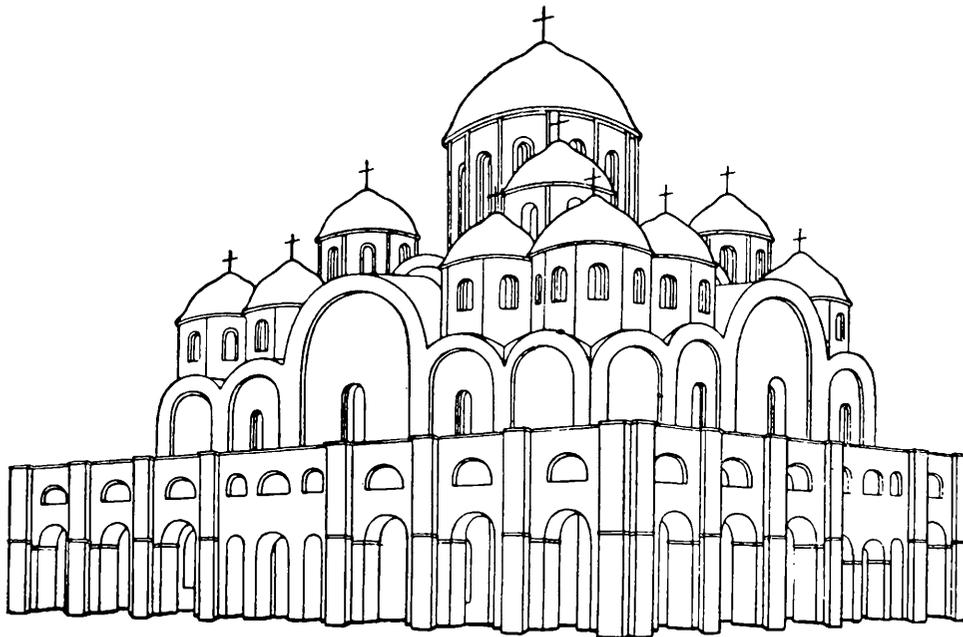
General view of Cathedral, restoration by Professor N. Brunov.
 Загальний вигляд катедрі. Реконструкція проф. Н. Брунова.

reconstruction proves the incorrectness of previous similar attempts (Academician Novytsky), agrees with him on only one point, namely, that the exterior gallery was added to the central, original body of the cathedral at a later date. Professor Brunov also imputes to Morhilevs'ky the view that both towers leading to the galleries were built simultaneously with this gallery.⁷⁷ But Morhilevs'ky never asserted that both towers were built at the same time;⁷⁸ on the contrary, in his lectures he was always careful to point out that the northwestern tower was built at (approximately) the same time as the original cathedral while the southwestern tower was erected in the 12th century.

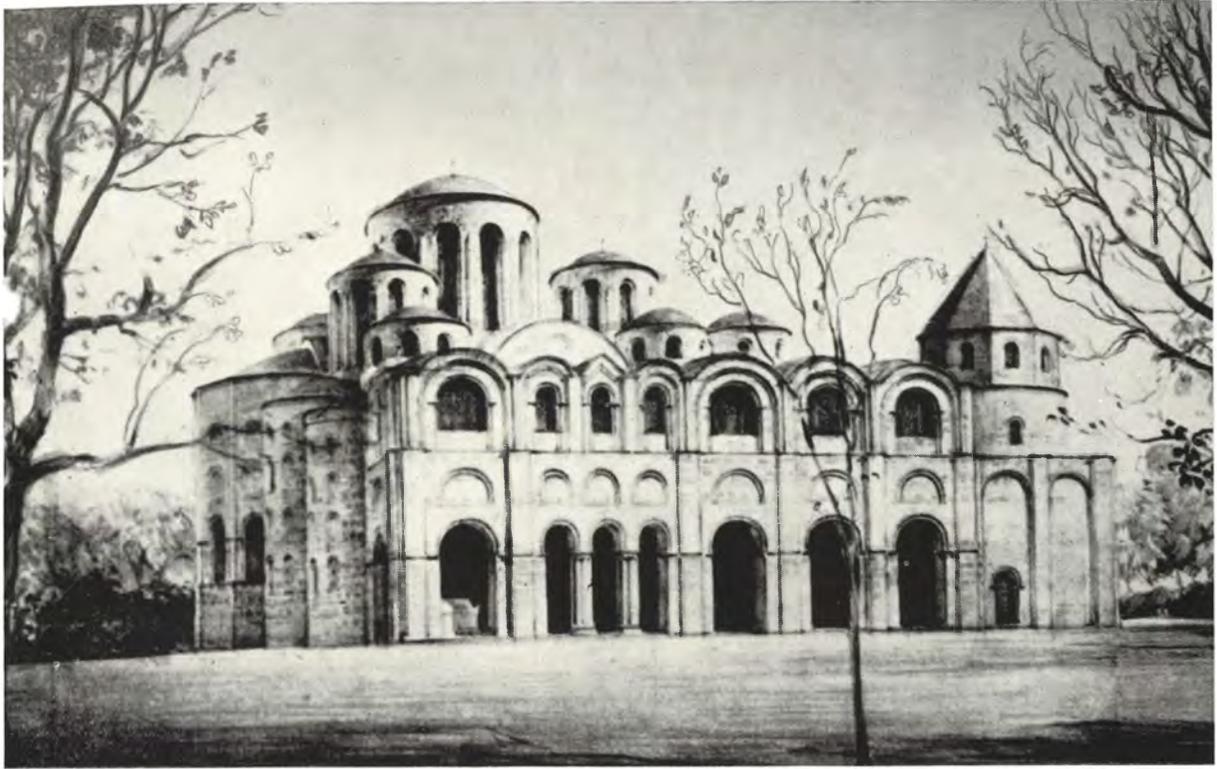
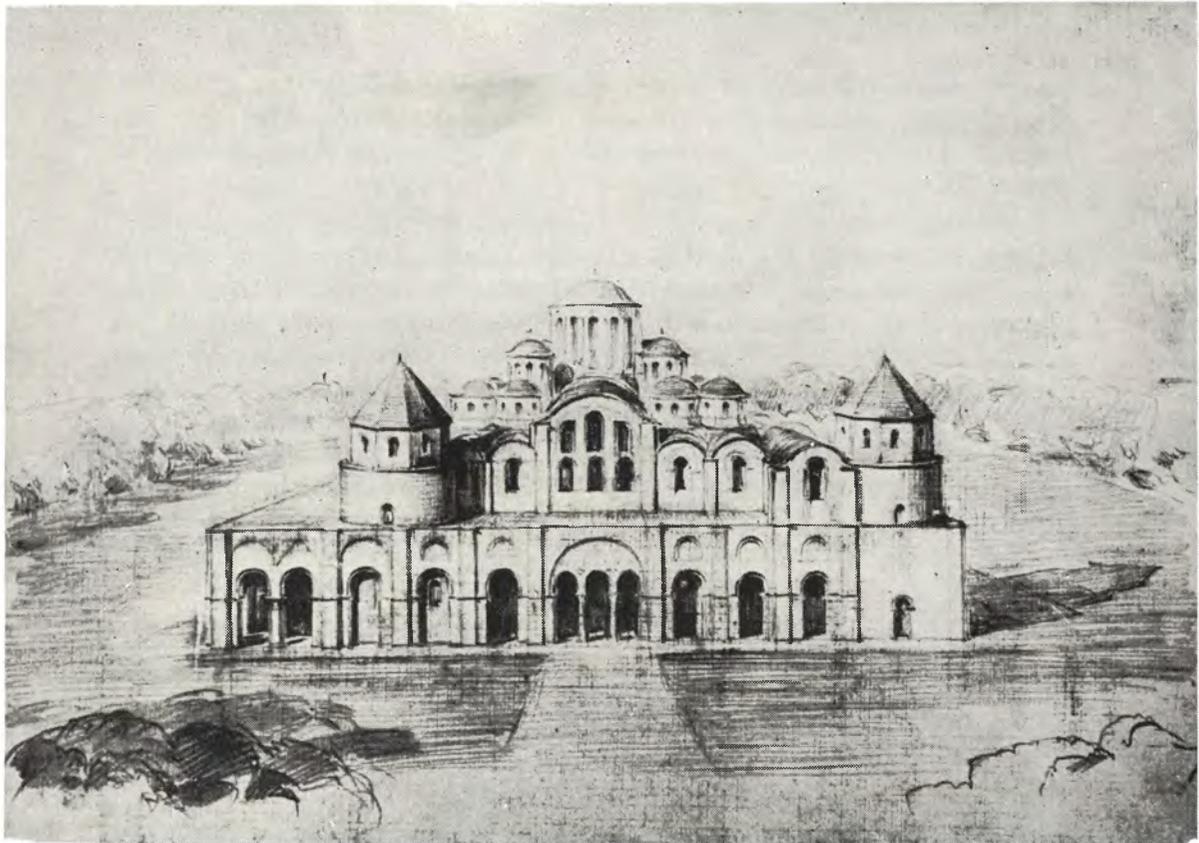
Above, north elevation of Cathedral; below, west elevation. Reconstruction by Professor K. J. Conant.
Північна (вгорі) й західня (внизу) фасади катедри. Реконструкція проф. К. Конанта.

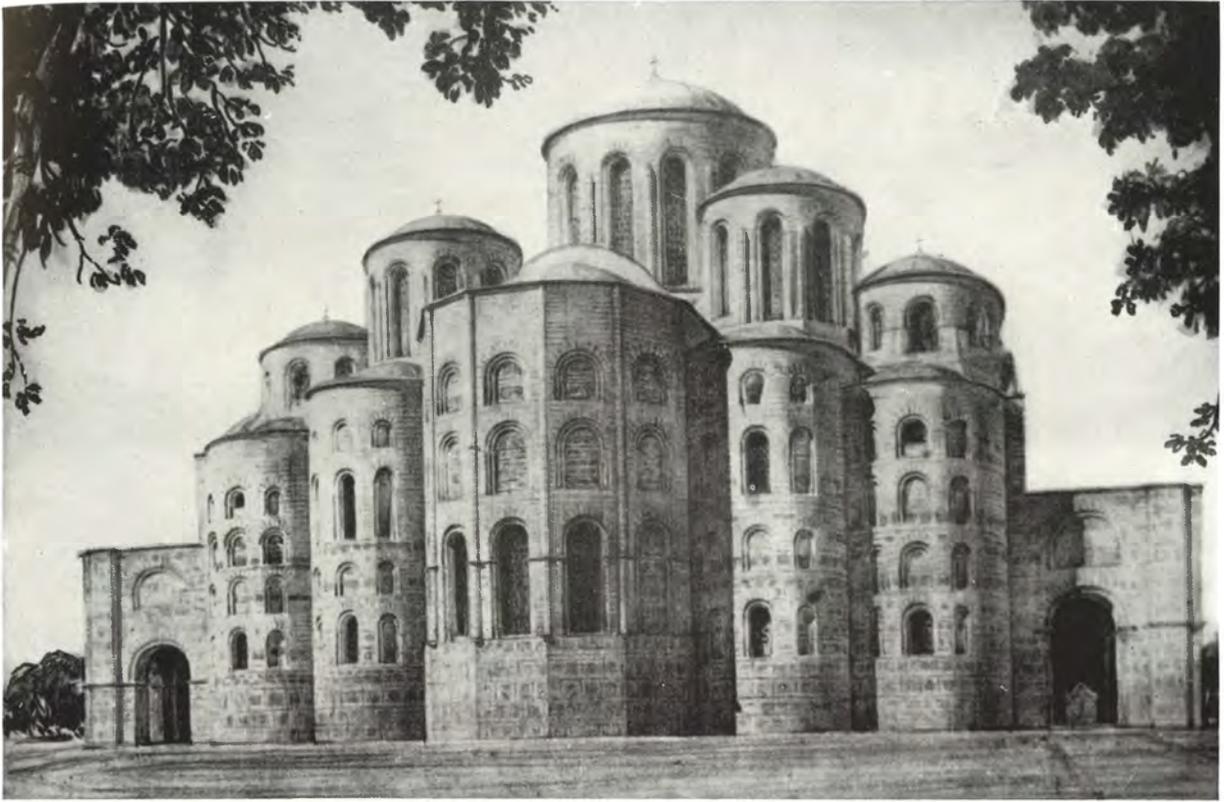
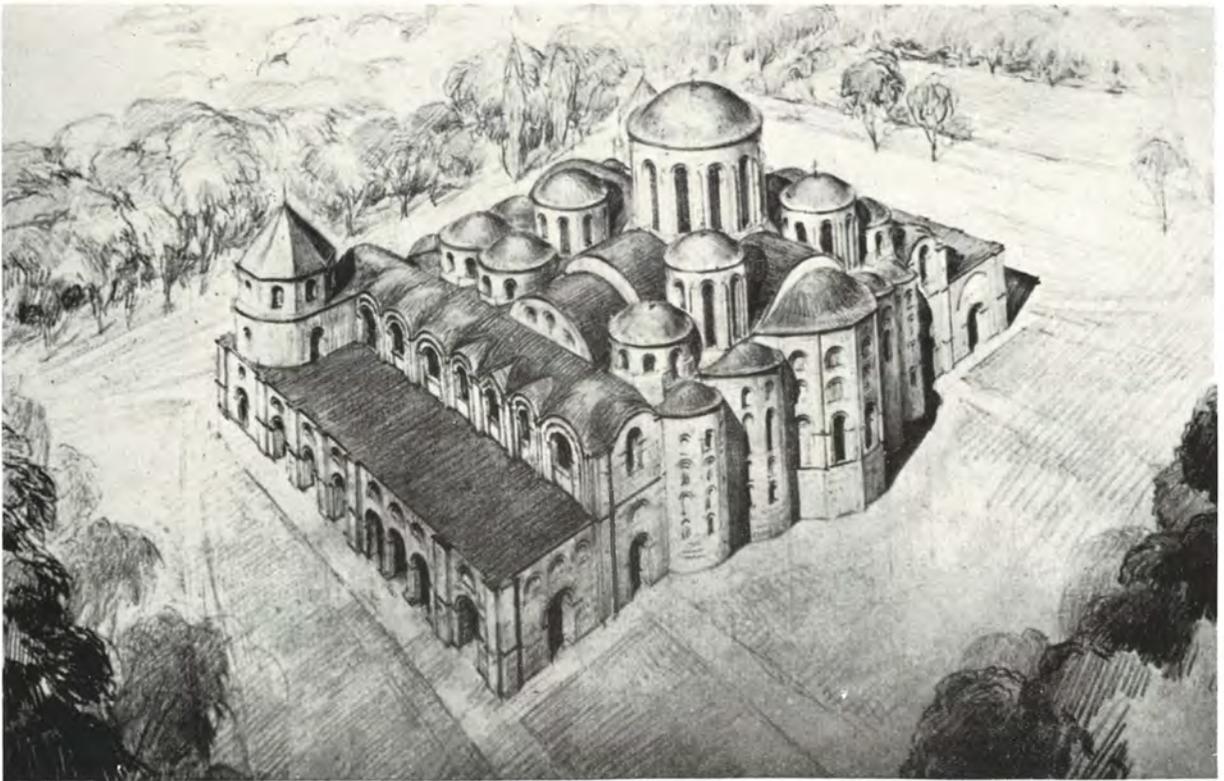
Above, east elevation before addition of outside galleries; below, aerial view after addition of outside galleries and southwestern tower. Restoration by Professor K. J. Conant.

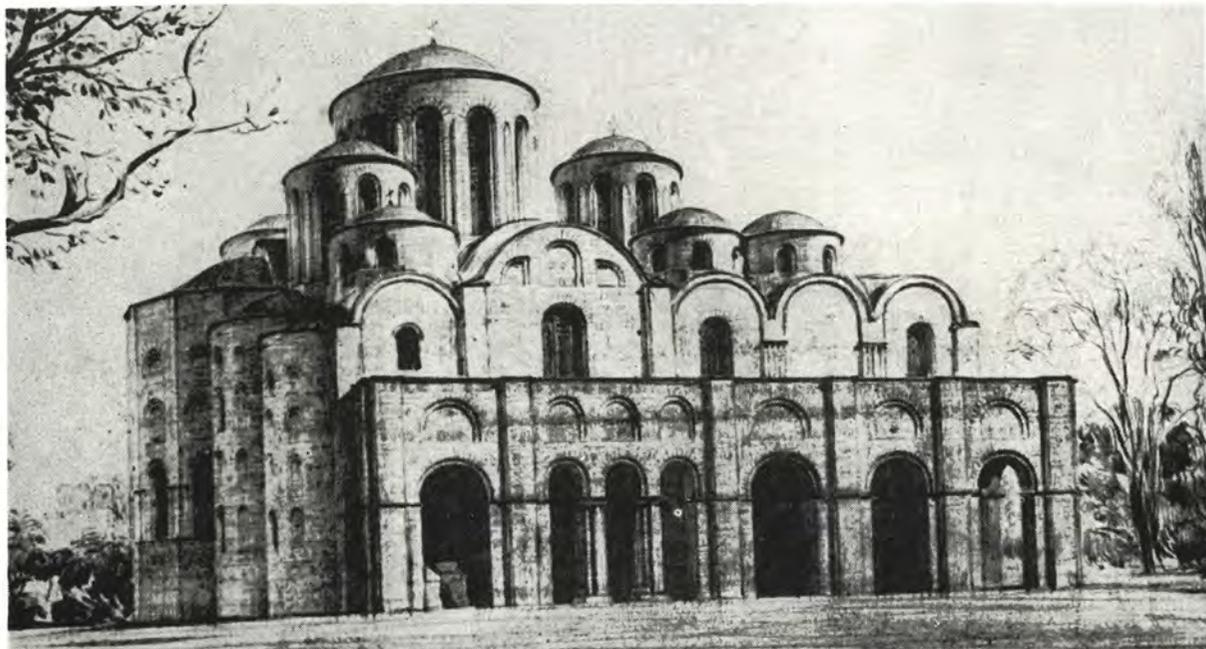
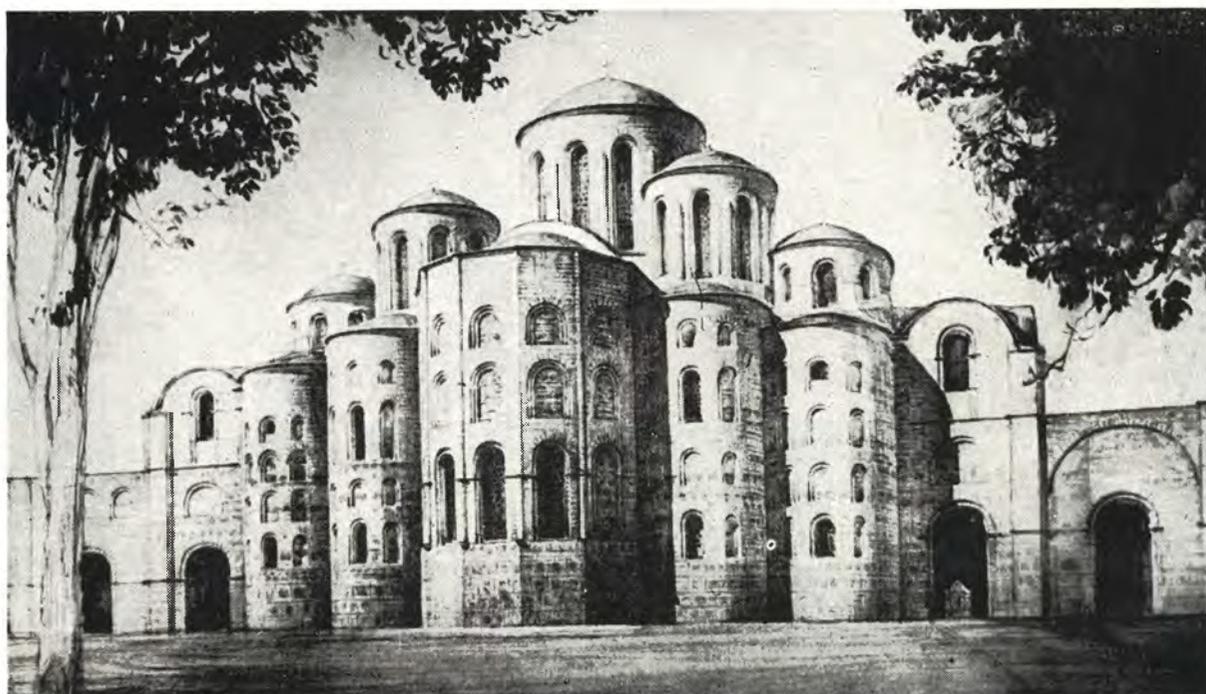
Above, north elevation before addition of outside galleries; below, east elevation after addition of outside galleries. Restoration by Professor K. J. Conant.

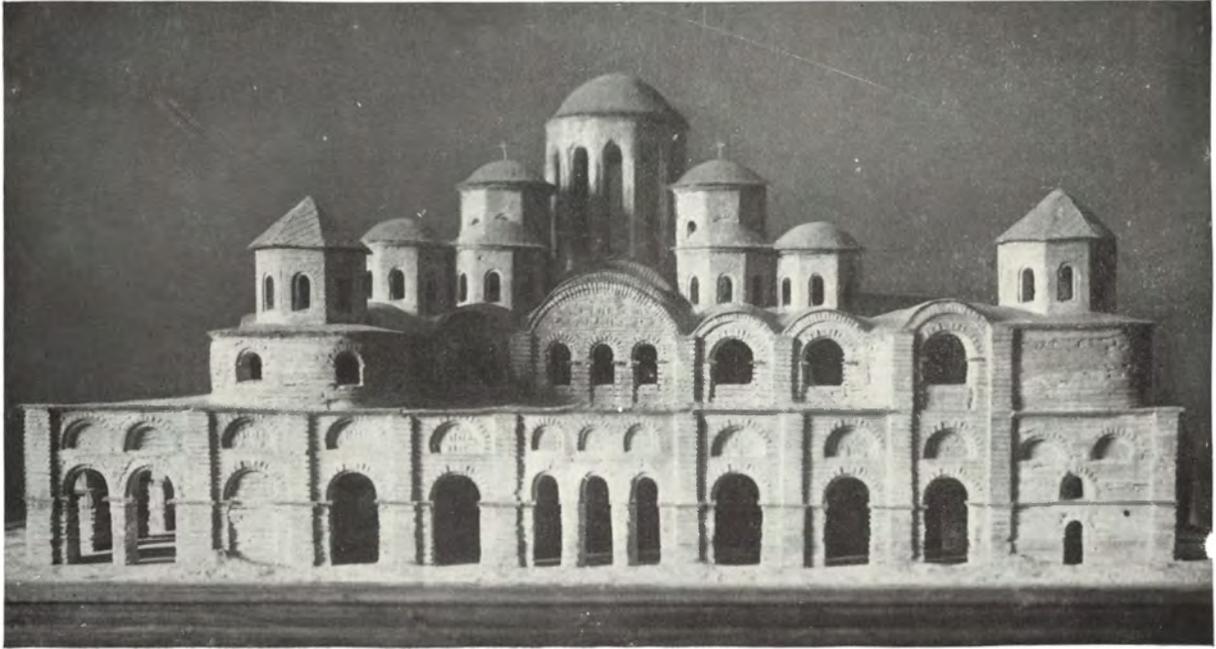
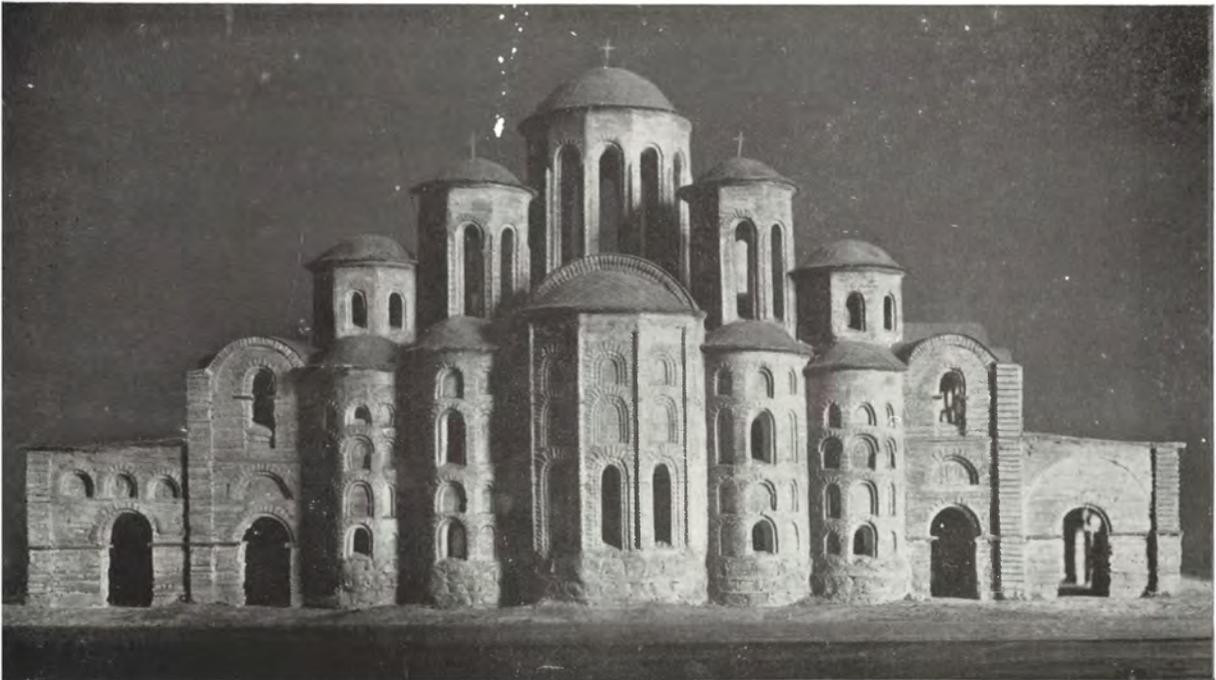
Above, west elevation and below, east elevation. Model reconstructed by St. Sophia Architectural and Historical Museum.

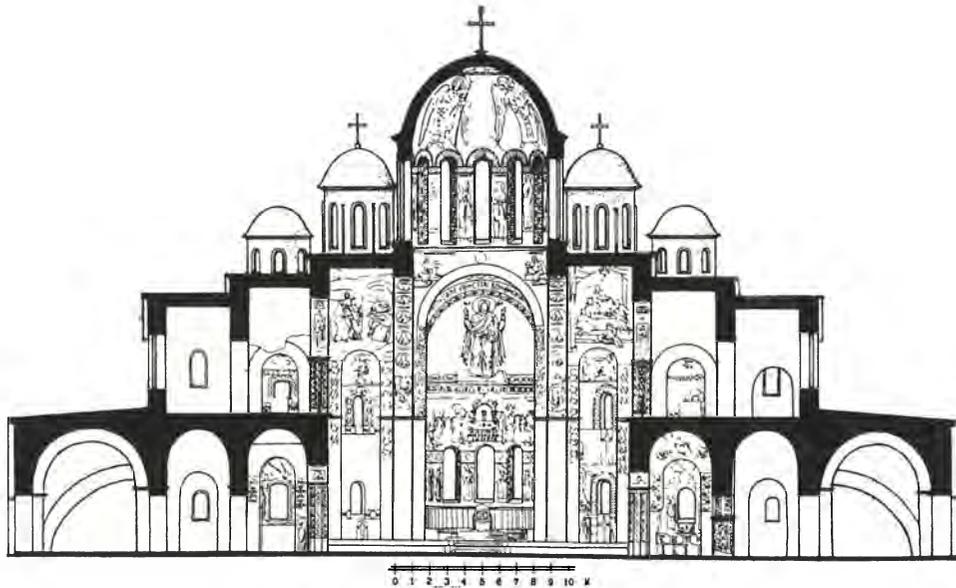
Preliminary study of longitudinal section, by author.
 Реконструкція подовжнього розрізу катедрі (автор).

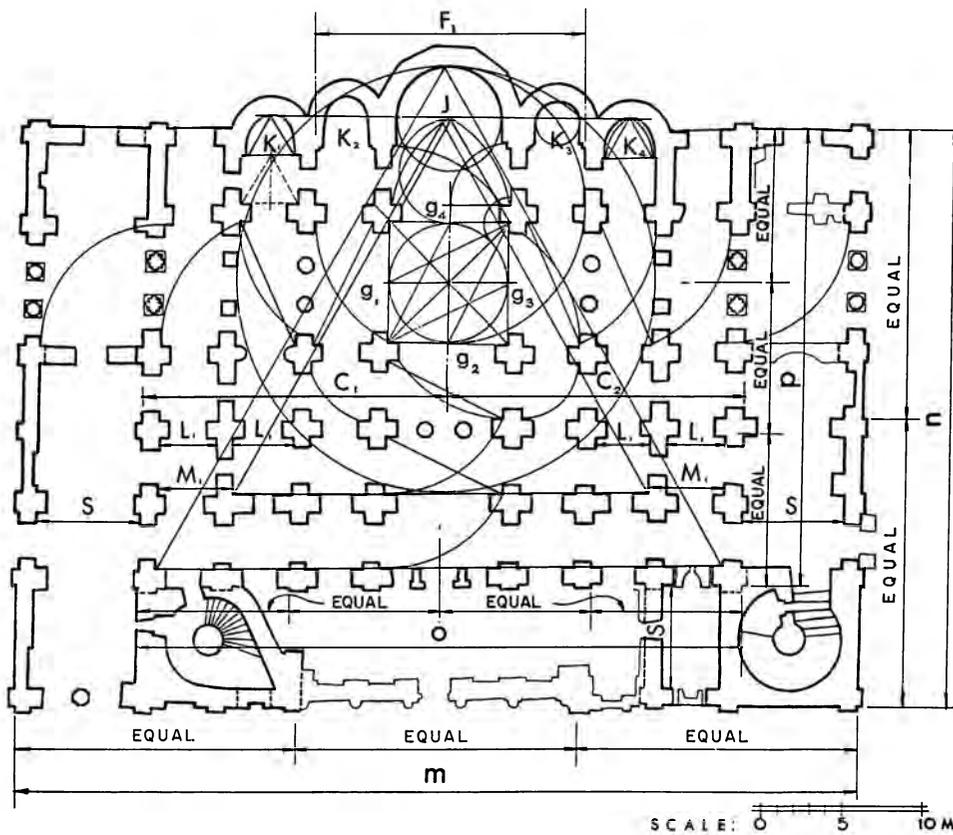
Architectural proportions in plan.

External and internal dimension proportions: $m : n = 3 : 2$; $o : p = 4 : 3$.

For source of architectural proportions in plan and section of St. Sophia Cathedral, see: K. M. Afanas'ev, "Pro proporsional'nist' pamyatnykiv drevnerus'koyi arkhitektury XI-XII st.", "Arkhitekturni pamyatnyky", ed. S. Ya. Hrabovs'ky, (A. A. URSR, Kiev, 1950), pp. 49-53.

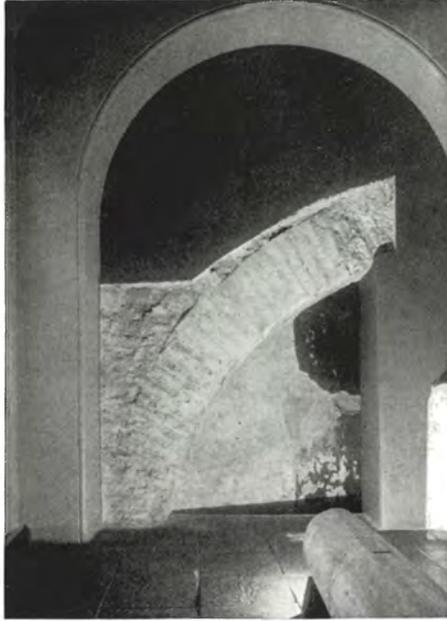
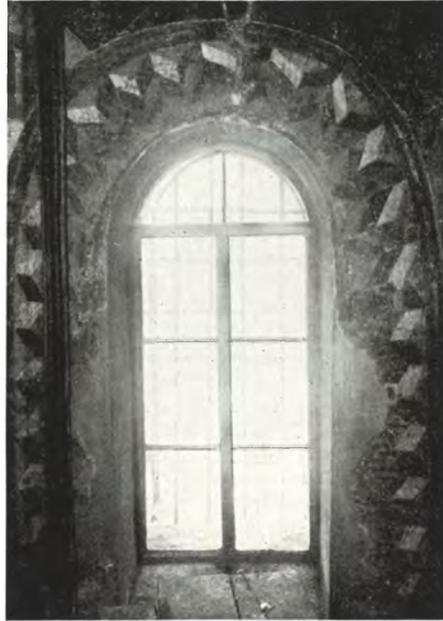
Left, flying buttress of the western exterior gallery (uncovered by Professor Morhilevs'ky in 1939). Right, window of the altar viewed from inside.

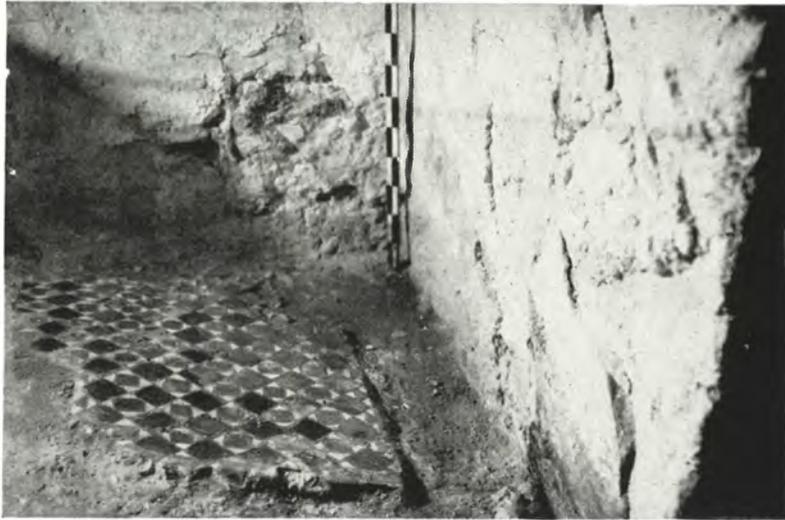
Fragment of the 11th century mosaic floor.
Фрагмент мозаїчної підлоги 11 ст.

In the better preserved parts of the 11th century floor foundations, however, it is possible to follow the technical process used in the mosaic work of that time. The preparation of the surface consisted in the laying of three beds. The first, a rendering of lime mortar with brick dust, received, after smoothing and hardening, a thin layer of mortar. Upon this still wet intermediate bed, the outline of the mosaic design was made with some sharp metal instrument. The mosaicist followed this sketch in setting the tessellae in the (third) wet setting bed of the floor. The exactitude with which the trimmings, circles and the design of the composition were executed points to the use of rule and compass by the artisans.

Four mosaic fragments were disclosed during the excavations, the best preserved being the fragment found between the piers of the southern triple arch of the main nave. In the same area, east of the southeastern pier, traces of early repair of the mosaic floor (not later than the 12th century) were discovered. This restoration was made necessary by the warping of the floor, caused by the settling of the pier. D. Mileev observed a similar phenomenon in the altar area of the cathedral.⁸⁵
