SURVEYS, ATTEMPTS AT RESTORATION, AND INVESTIGATIONS OF THE ARCHITECTURE OF THE CATHEDRAL OF ST. SOPHIA

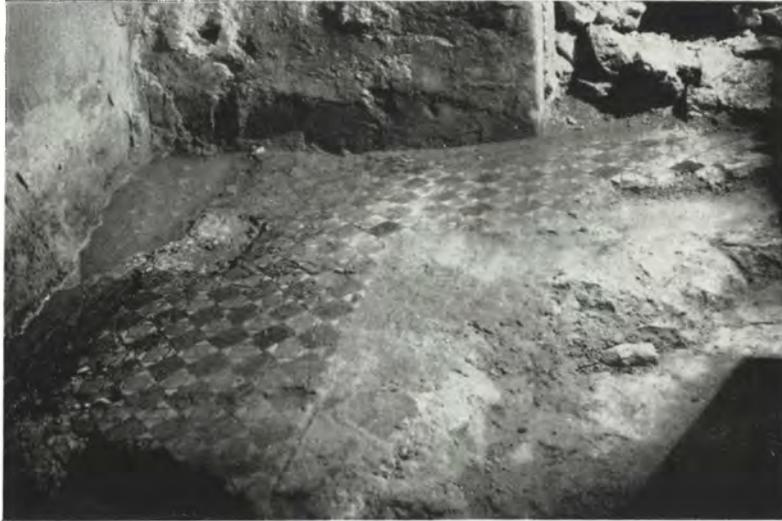
Fragment of 11th century mosaic floor.

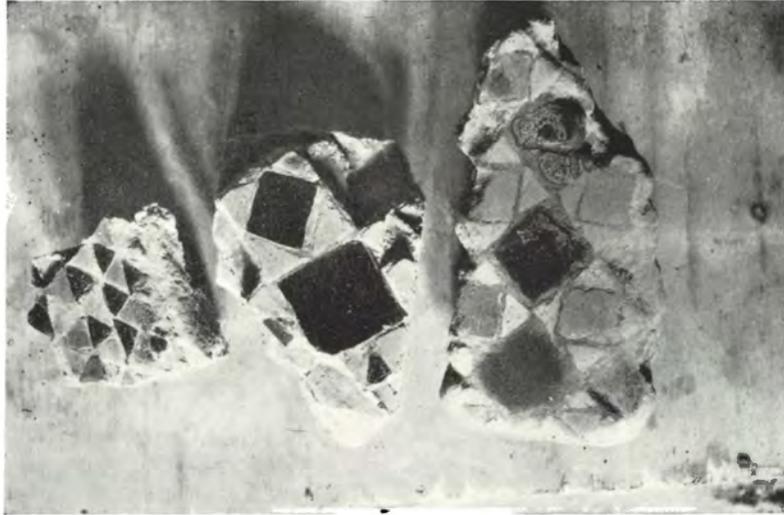
Fragments of the 11th century mosaic floor.
